Annual Inspection

Winchester City Council

Recreation Ground (Cheriton PC)

Westfield Road, Cheriton, Arlesford, Hampshire, SO24
0QH

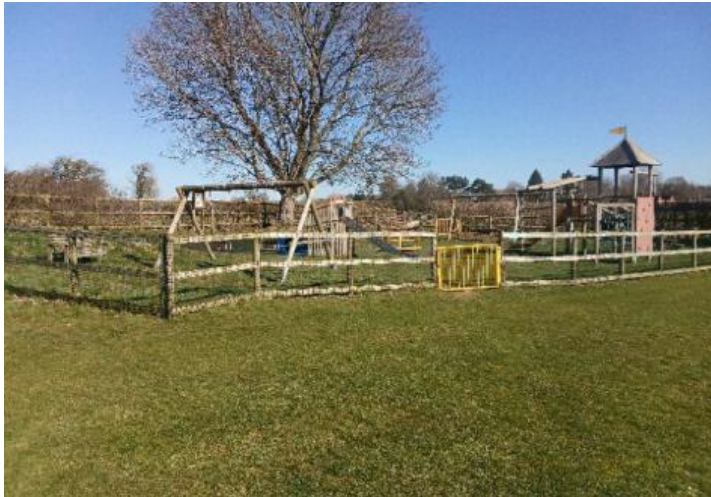
Item: Ancillary Items - Site General
Manufacturer: Owner/Operator

Finding: It is recommended that signage, with information including the site address, contact information for maintenance issues and emergency contact details are provided for the facility

Action: Provide in accordance with the recommendations

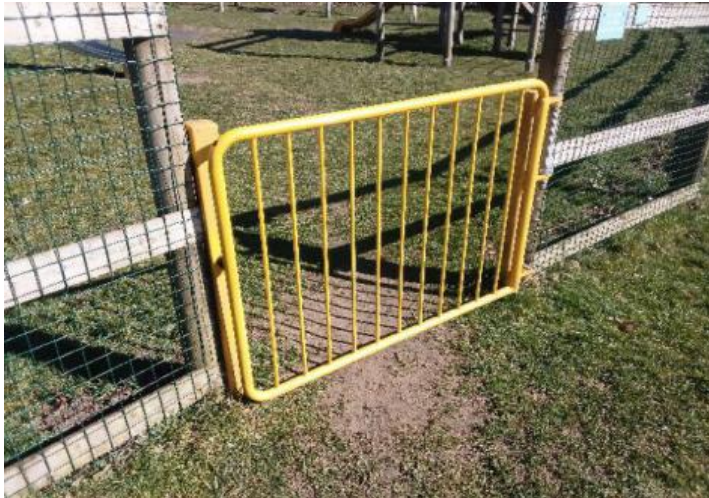
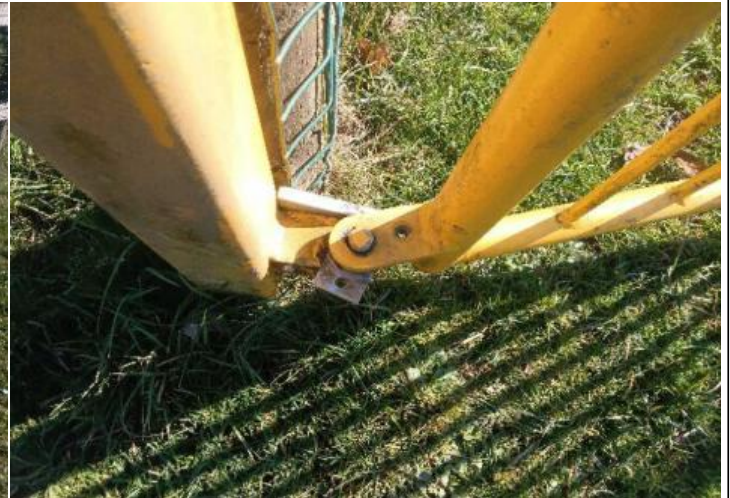
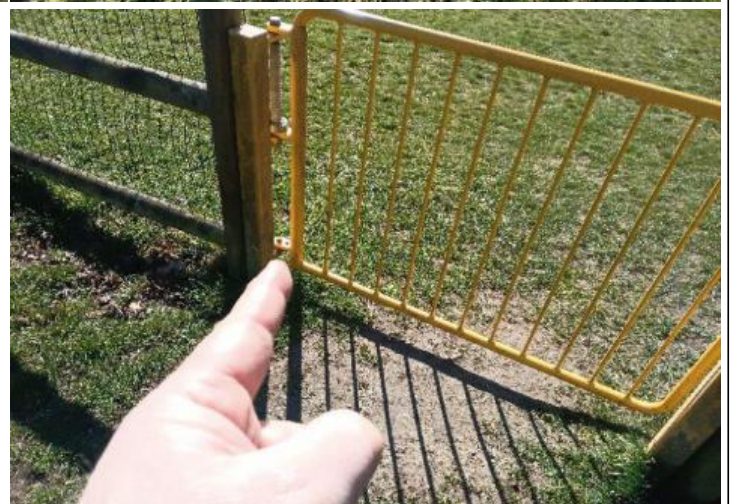
Item: Gates - Gate - Self Closing
Manufacturer: I.A.E. Fencing

Finding: There is a missing fixing and a bracket has slipped out of place with sharp edges **Action:** Repair

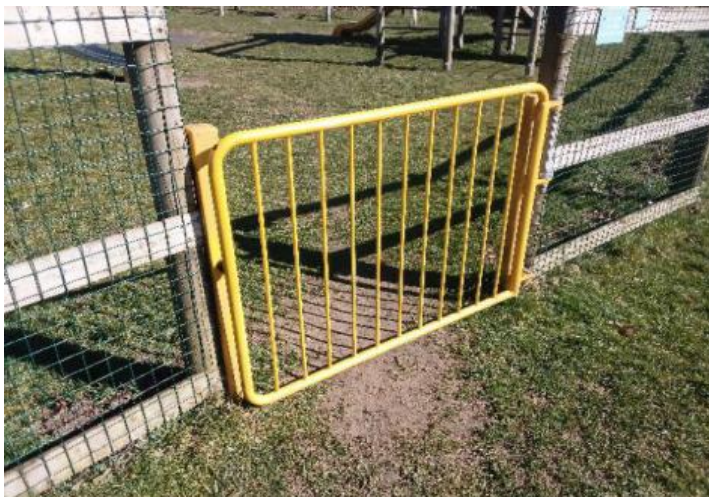
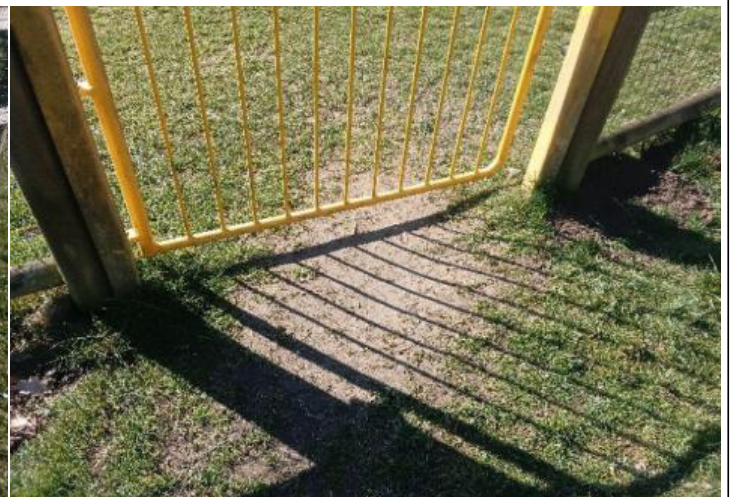
Item: Gates - Gate - Self Closing
Manufacturer: I.A.E. Fencing

Finding: The surface has eroded in some areas and may be slippery in wet conditions. **Action:** Reinstate the surface

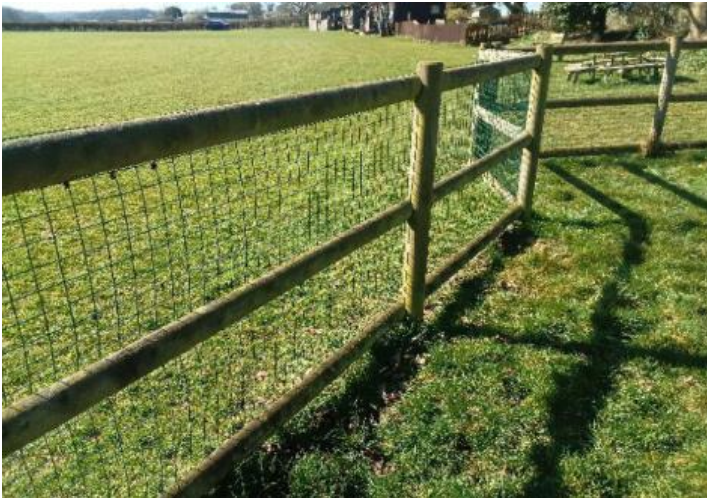
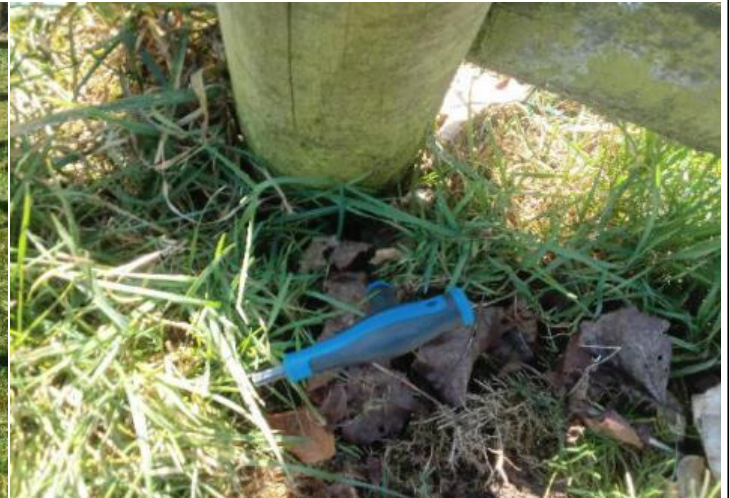
Item: Fences - Fence - Timber & Mesh Infill
Manufacturer: Not Identified

Finding: There is some evidence of rot in the timber

Action: Monitor for any further deterioration and replace as required

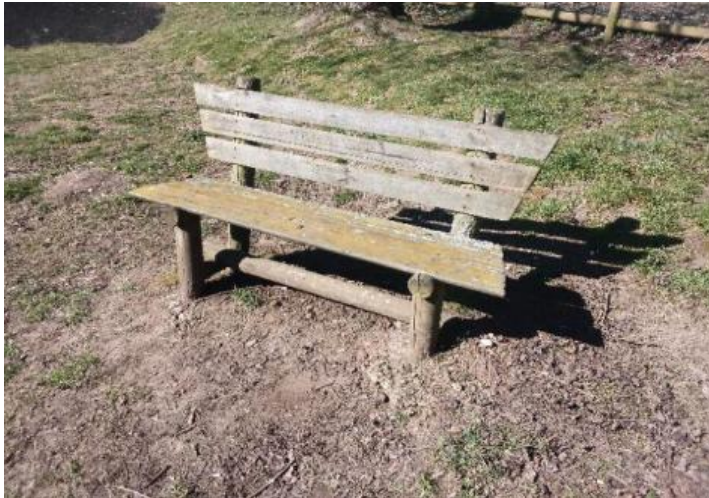
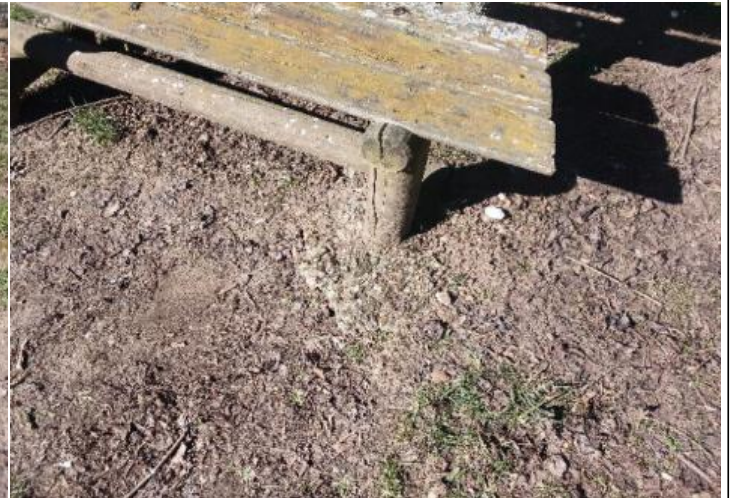
Item: Ancillary Items - Bench
Manufacturer: Not Identified

Finding: The surface has eroded and the foundations are exposed

Action: Reinstate surrounding surfaces to cover the foundations

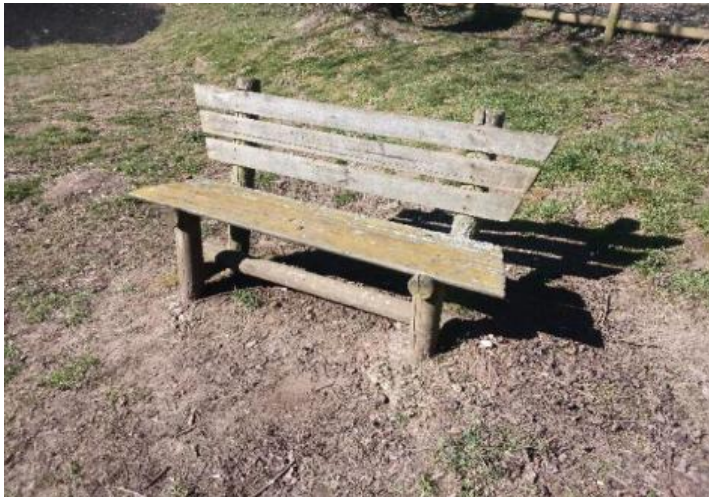
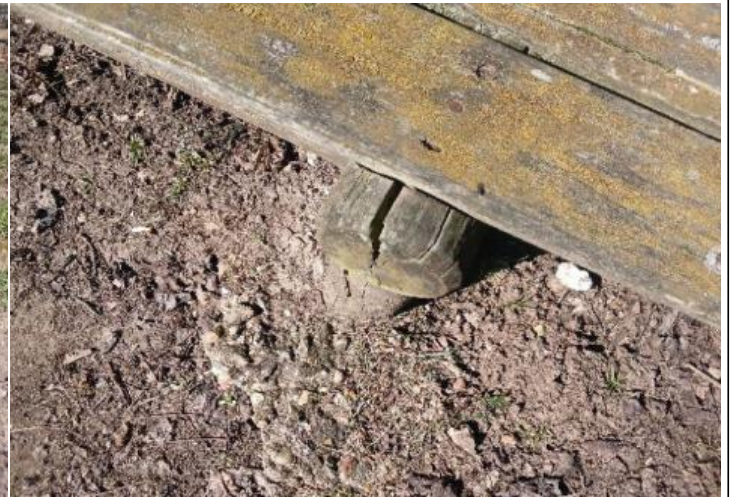
Item: Ancillary Items - Bench
Manufacturer: Not Identified

Finding: The timber has a number of splits/shakes or air cracks and this may affect the stability or allow water ingress which will accelerate the rotting process

Action: Monitor to ensure the splits do not cross through fixing points of the structure and/or cause any instability

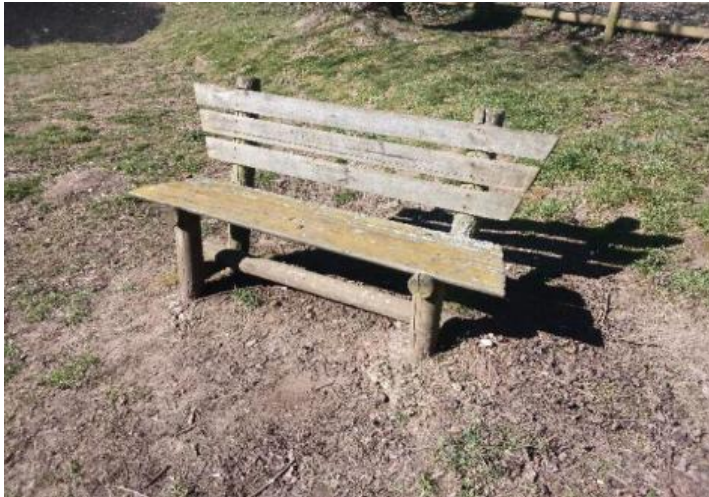
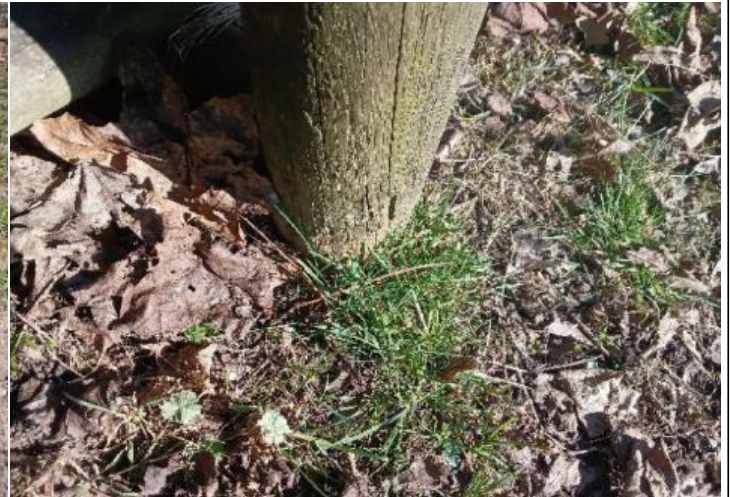
Item: Ancillary Items - Bench
Manufacturer: Not Identified

Finding: There is some strimmer / machinery damage apparent on the posts, this can penetrate the preservative applied to the timber and accelerate the rotting process

Action: Monitor for any deterioration (rot) and replace as required

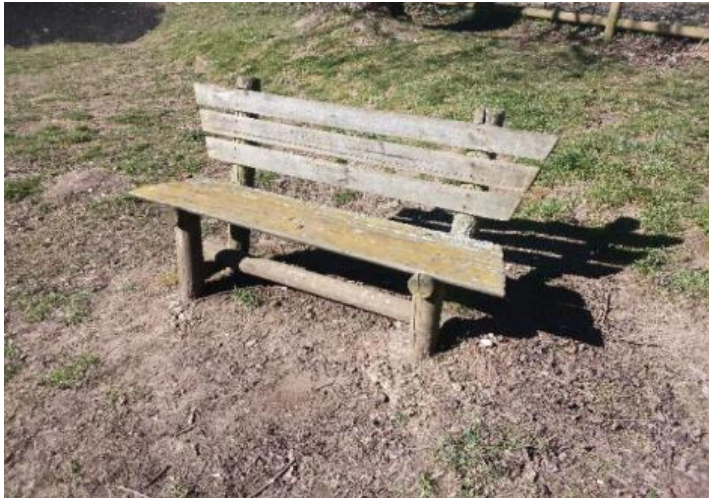
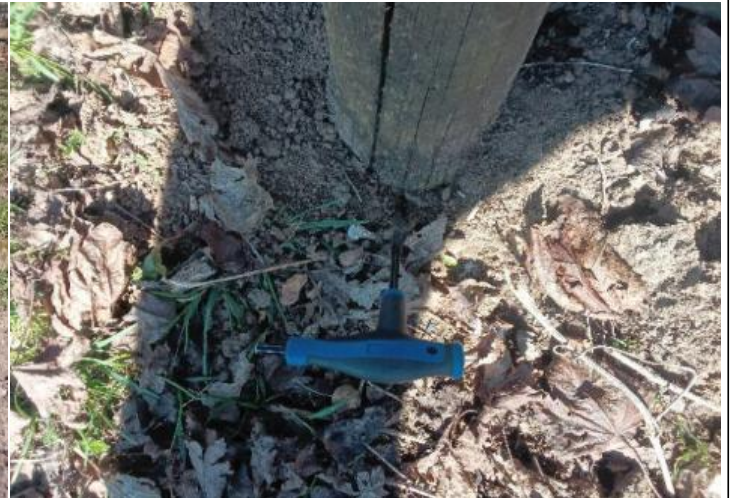
Item: Ancillary Items - Bench
Manufacturer: Not Identified

Finding: There is some evidence of rot in the timber

Action: Monitor for any further deterioration and replace as required

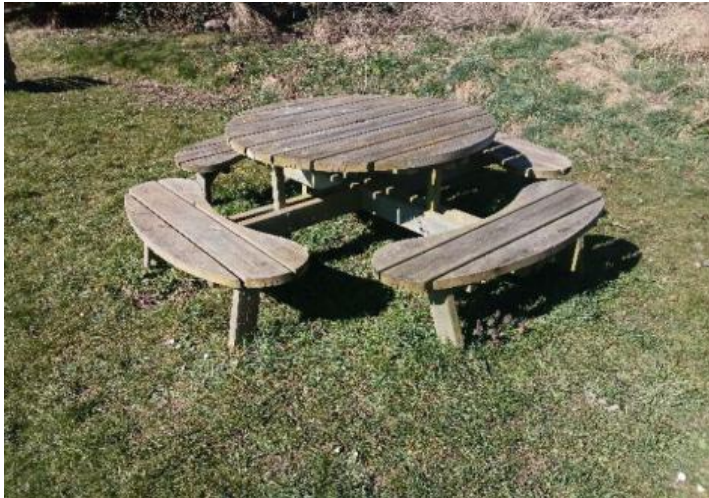
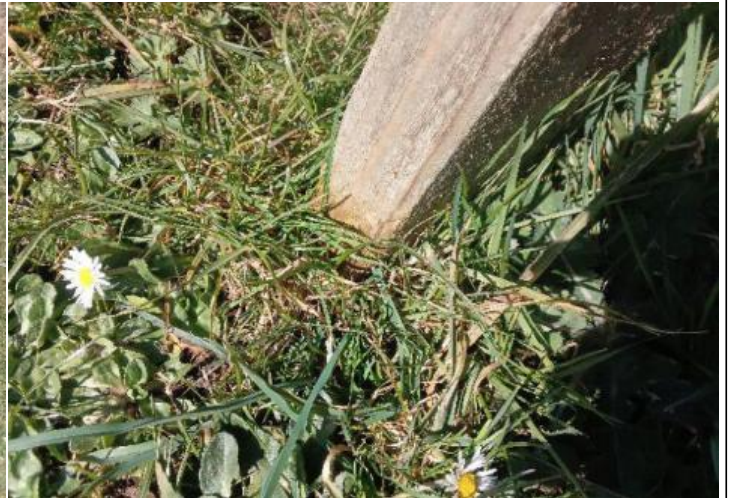
Item: Ancillary Items - Picnic Table
Manufacturer: Not Identified

Finding: There is some strimmer / machinery damage apparent on the posts, this can penetrate the preservative applied to the timber and accelerate the rotting process

Action: Monitor for any deterioration (rot) and replace as required

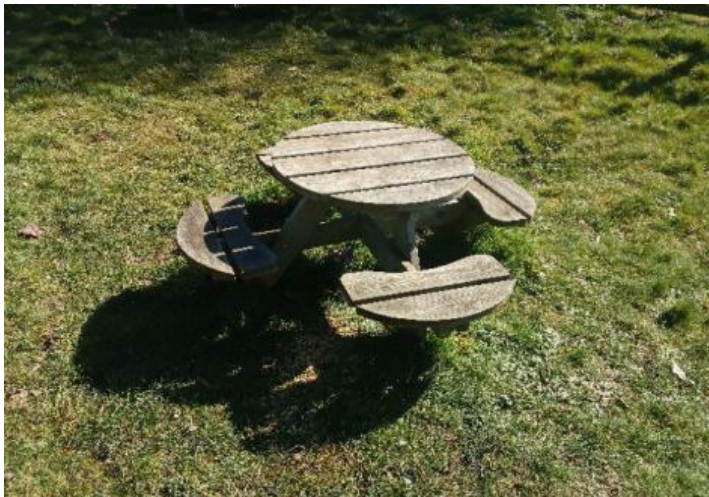
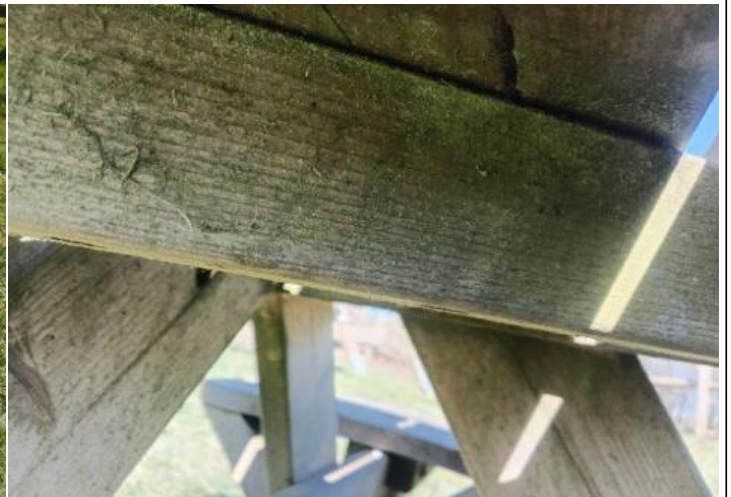
Item: Ancillary Items - Picnic Table
Manufacturer: Not Identified

Finding: A number of fixing(s) have worked loose

Action: Secure all loose fixings

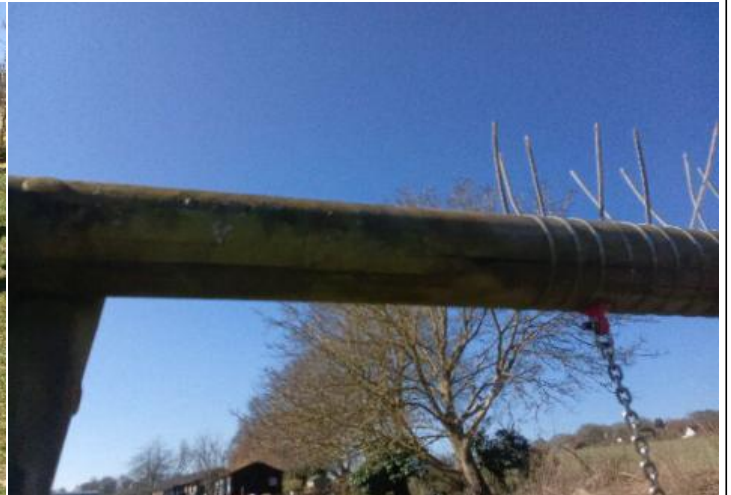
Item: Swings - 1 Bay 2 Seat (Cradle)
Manufacturer: Obra

Finding: There is algae or moss on the surface of the equipment that can lead to the onset of rot

Action: Monitor condition of the timbers (rot), clean and treat appropriately

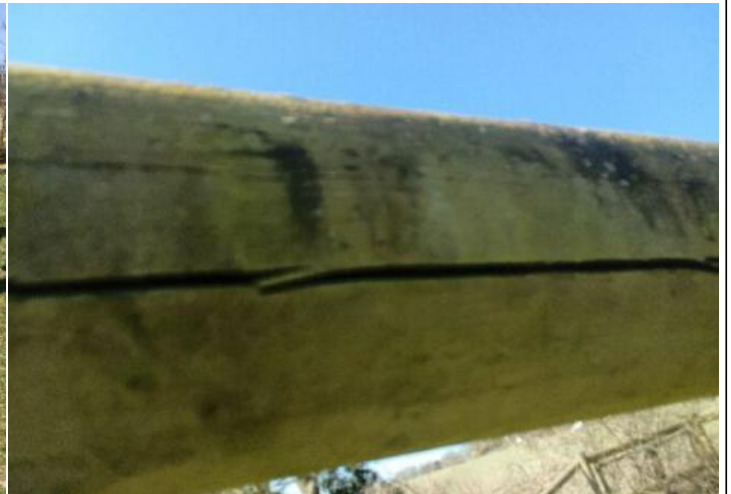
Item: Swings - 1 Bay 2 Seat (Cradle)
Manufacturer: Obra

Finding: The timber has a number of splits/shakes or air cracks and this may affect the stability or allow water ingress which will accelerate the rotting process

Action: Monitor to ensure the splits do not cross through fixing points of the structure and/or cause any instability

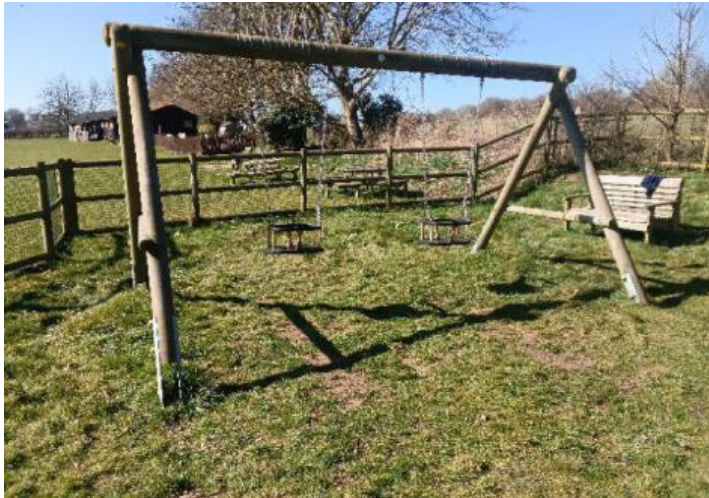
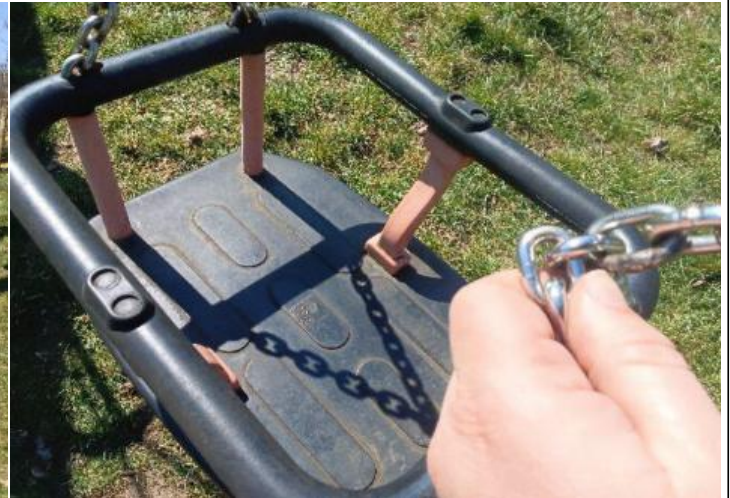
Item: Swings - 1 Bay 2 Seat (Cradle)
Manufacturer: Obra

Finding: There is some notable evidence of chain wear

Action: Monitor for any further deterioration and replace when 40% worn

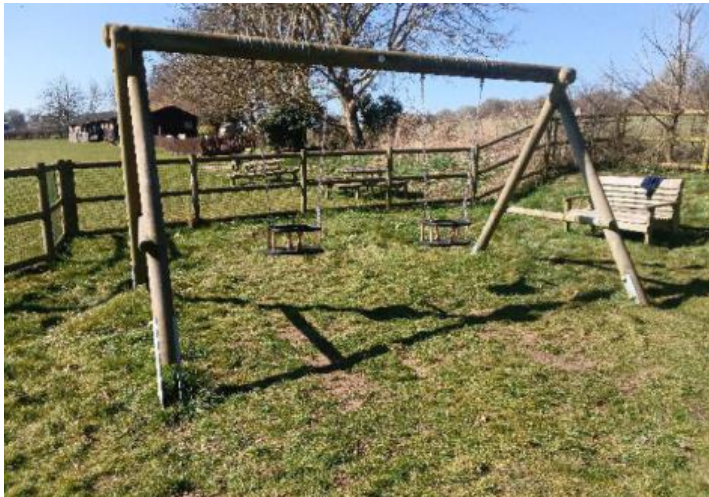
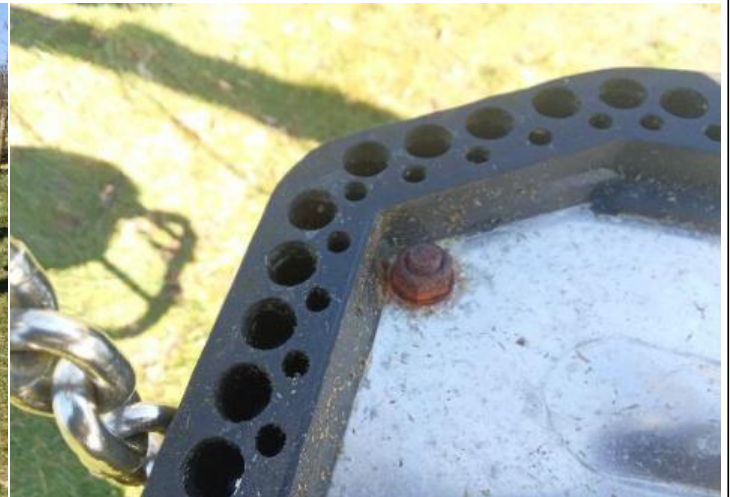
Item: Swings - 1 Bay 2 Seat (Cradle)
Manufacturer: Obra

Finding: The fixings have corroded excessively

Action: Replace all corroded fixings

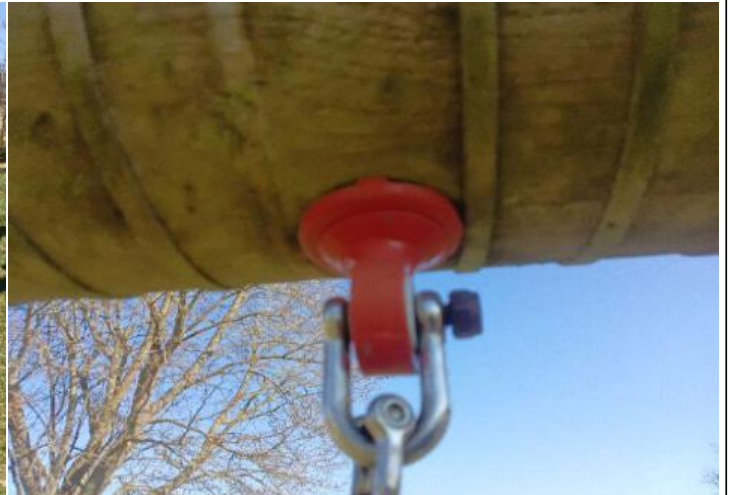
Item: Swings - 1 Bay 2 Seat (Cradle)
Manufacturer: Obra

Finding: A number of shackle fixing(s) have worked loose **Action:** Secure all loose fixings

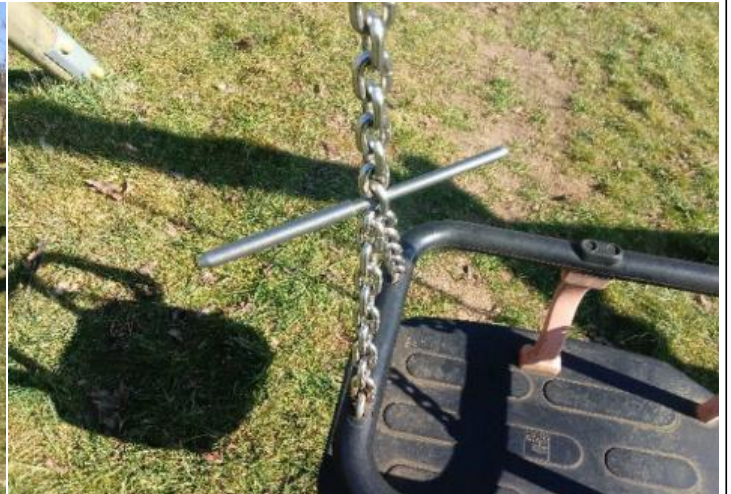
Item: Swings - 1 Bay 2 Seat (Cradle)
Manufacturer: Obra

Finding: The chain openings are in excess of the 8.6mm as recommended by BS EN 1176 **Action:** Monitor - No action given the risk assessment

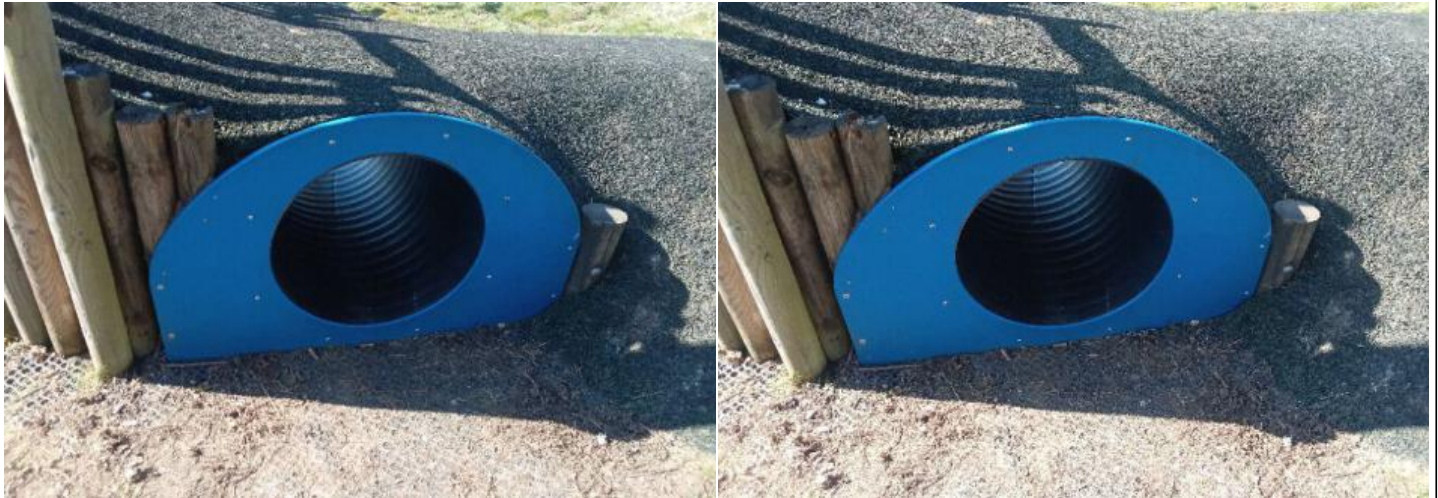
Item: Other - Tunnel Mound
Manufacturer: Obra

Finding: This design / configuration of tunnel mound is well established and has been successfully included in large quantities of playgrounds throughout the UK. Whilst the design does not fully meet the requirements of BS EN 1176 with regards to falls in excess of 600mm over the edge of the tunnel to the surface below, it has been risk assessed as fit for purpose in this regard and no changes are recommended to the design unless otherwise stated in additional findings

Action: Monitor - No action given the risk assessment

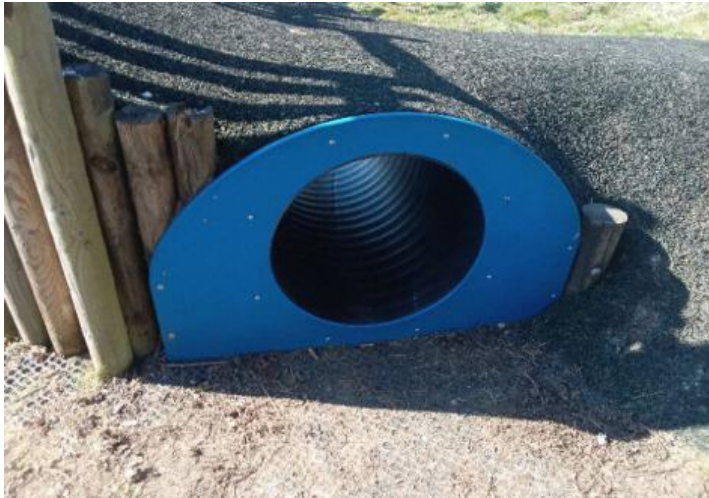
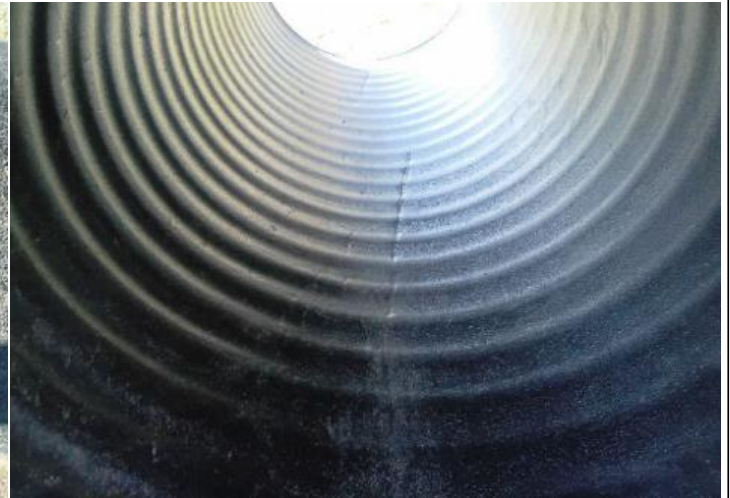
Item: Other - Tunnel Mound
Manufacturer: Obra

Finding: There is some damage to the tunnel surface

Action: Monitor for any further deterioration and repair as required

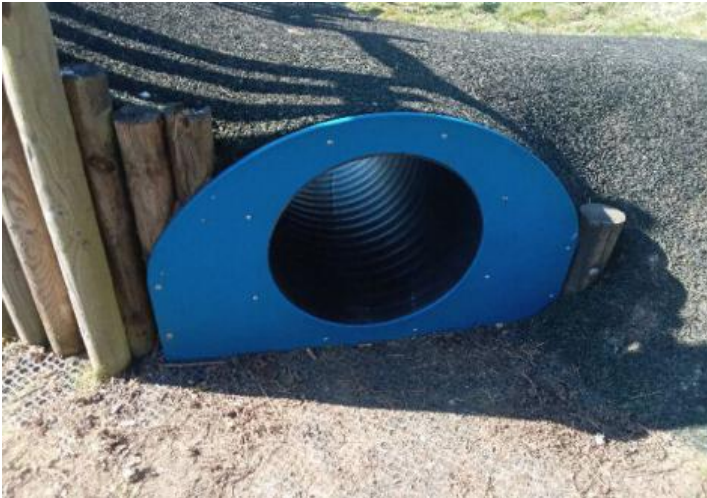
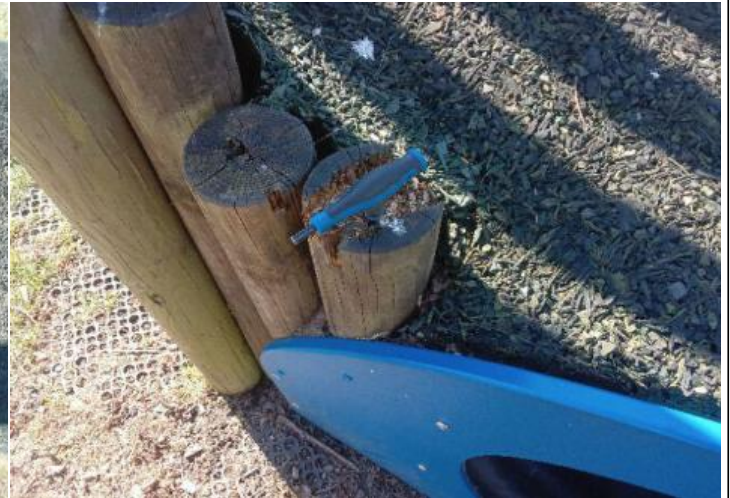
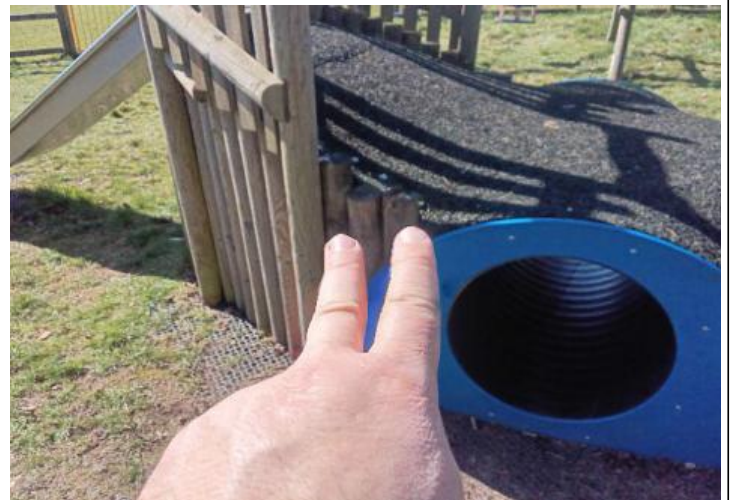
Item: Other - Tunnel Mound
Manufacturer: Obra

Finding: There are areas or parts of the timber on the structure that have rotted

Action: Replace all affected timbers

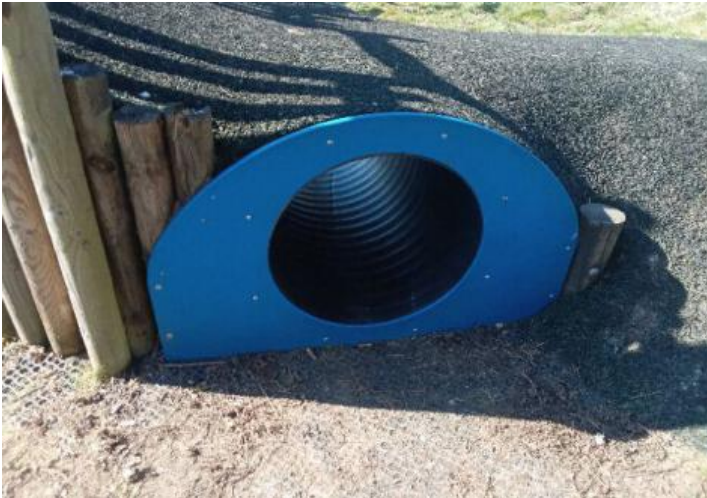
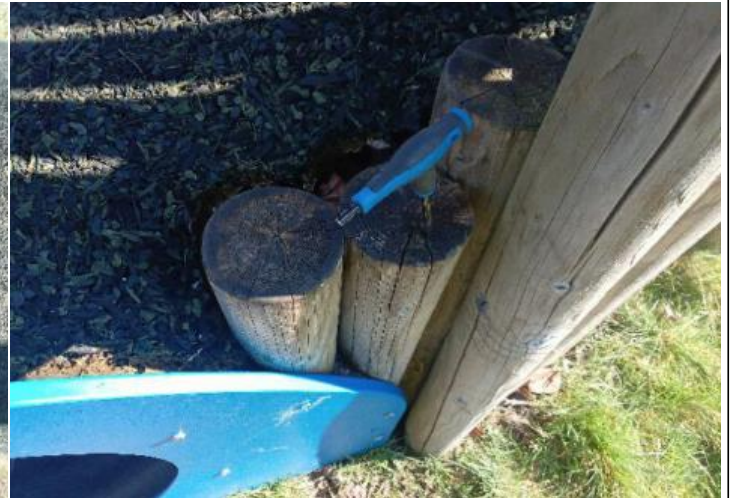
Item: Other - Tunnel Mound
Manufacturer: Obra

Finding: There is some evidence of rot in the timber

Action: Monitor for any further deterioration and replace as required

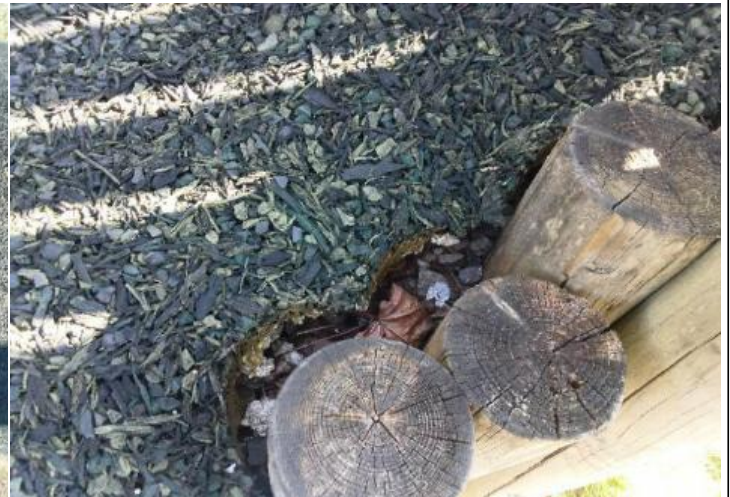
Item: Other - Tunnel Mound
Manufacturer: Obra

Finding: There are significant gaps (over 30mm) between the surface and the edging or between the joints in the surface; these are large enough for a small foot to enter

Action: Repair surfacing

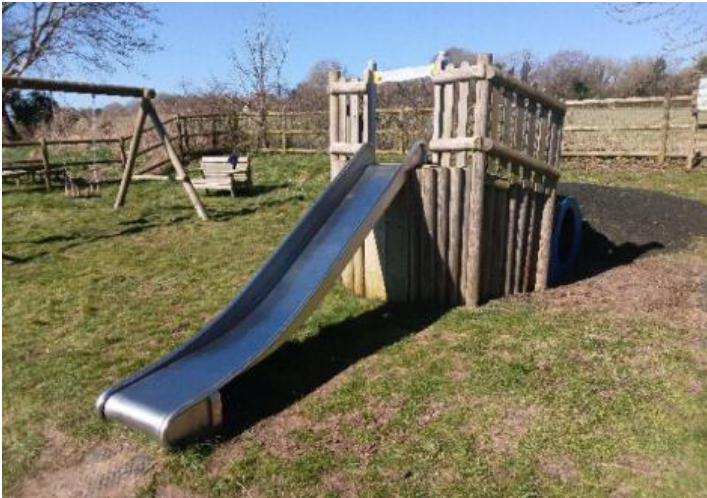
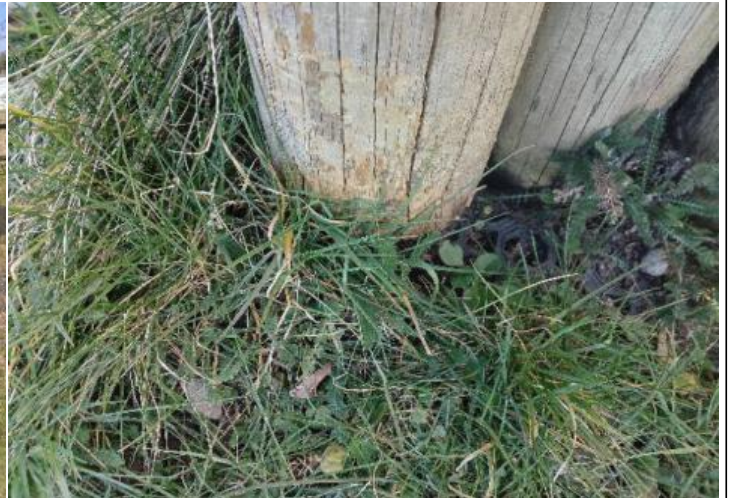
Item: Activity Equipment - Multi Play (Junior)
Manufacturer: Obra

Finding: There is some strimmer / machinery damage apparent on the posts, this can penetrate the preservative applied to the timber and accelerate the rotting process

Action: Monitor for any deterioration (rot) and replace as required

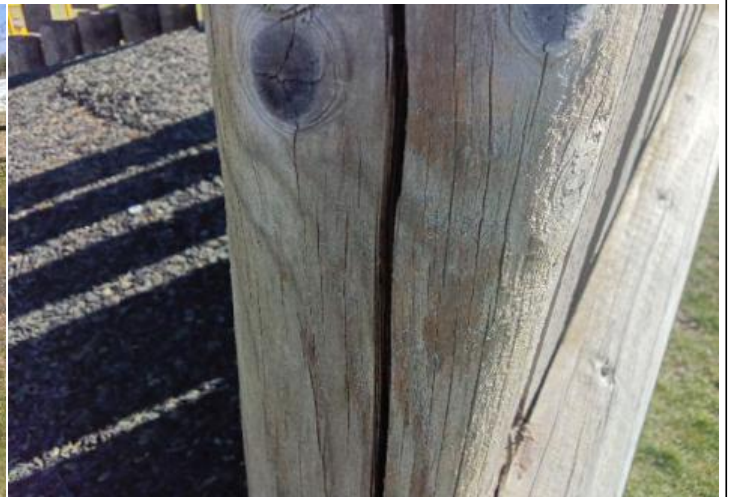
Item: Activity Equipment - Multi Play (Junior)
Manufacturer: Obra

Finding: The timber has a number of splits/shakes or air cracks and this may affect the stability or allow water ingress which will accelerate the rotting process

Action: Monitor to ensure the splits do not cross through fixing points of the structure and/or cause any instability

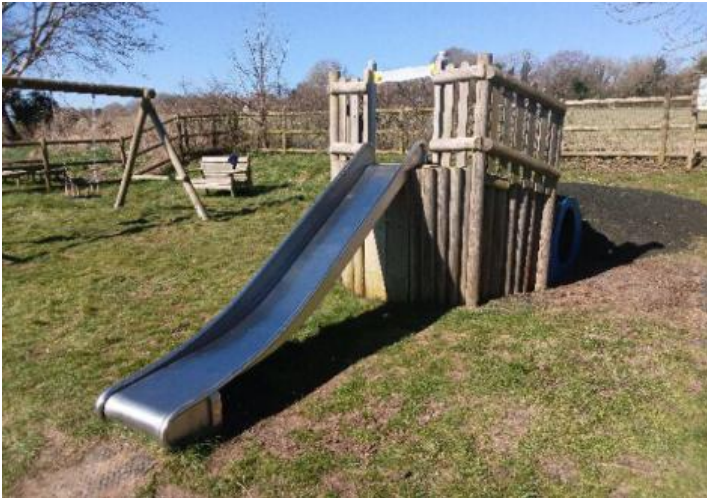
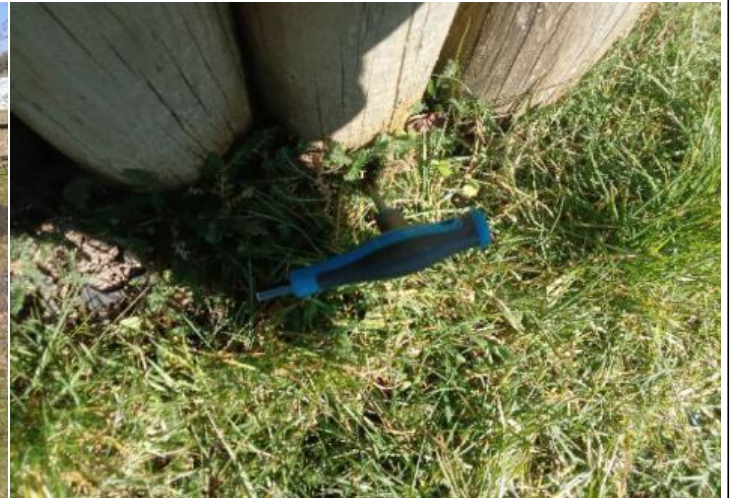
Item: Activity Equipment - Multi Play (Junior)
Manufacturer: Oبرا

Finding: There is some evidence of rot in the timber

Action: Monitor for any further deterioration and replace as required

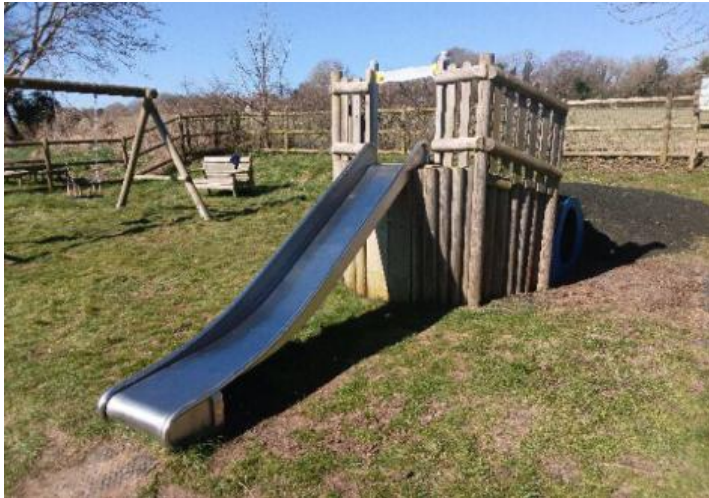
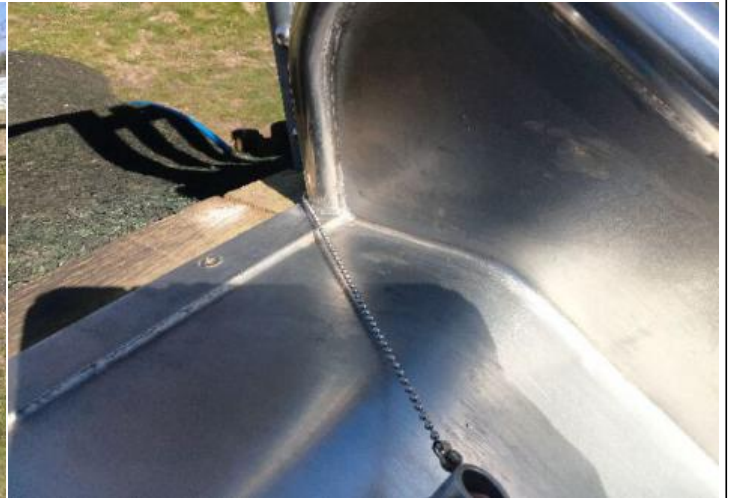
Finding: There is / are toggle entrapment/s present in contravention of the recommendations set out in BS EN 1176 Part 1

Action: Monitor - No action given the risk assessment

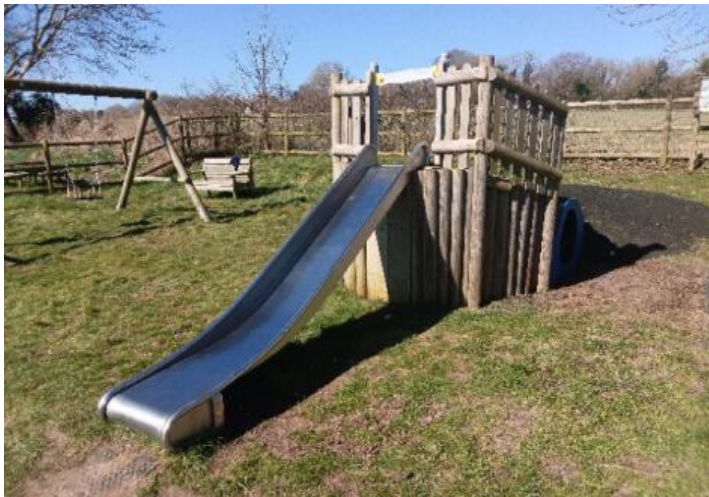
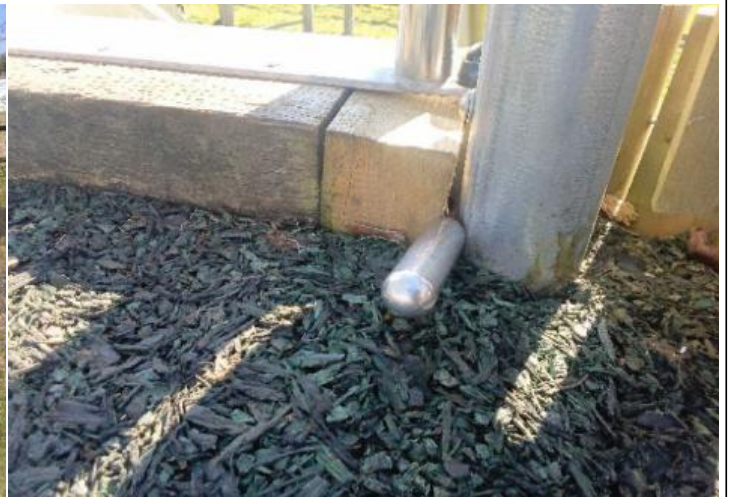
Finding: There is/are finger entrapment/s leading to the slide and the item fails to meet the requirements of BS EN 1176 Part 1 4.2.7.6 Entrapment of fingers

Action: Monitor - No action given the risk assessment

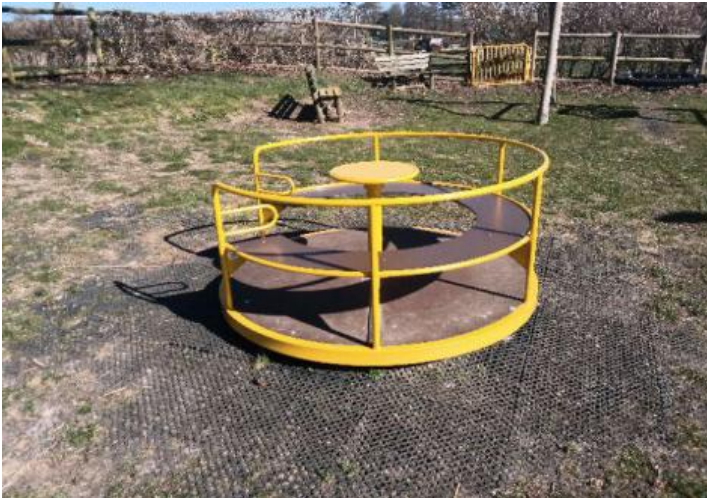
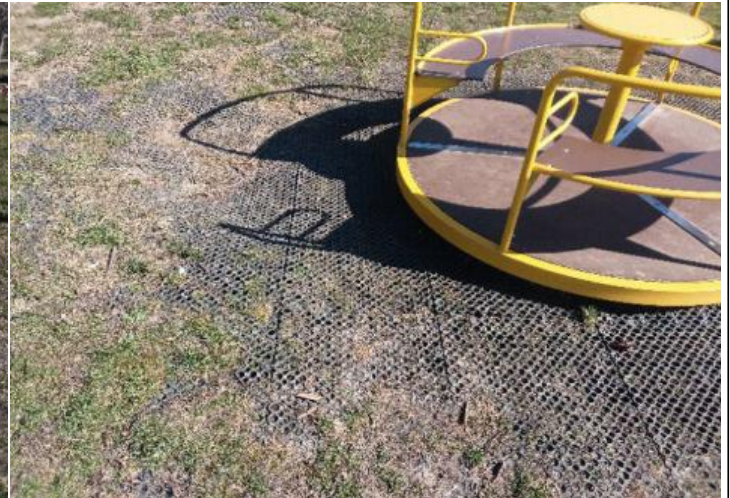
Finding: The surface has subsided in some areas

Action: Monitor for any further deterioration and repair as required

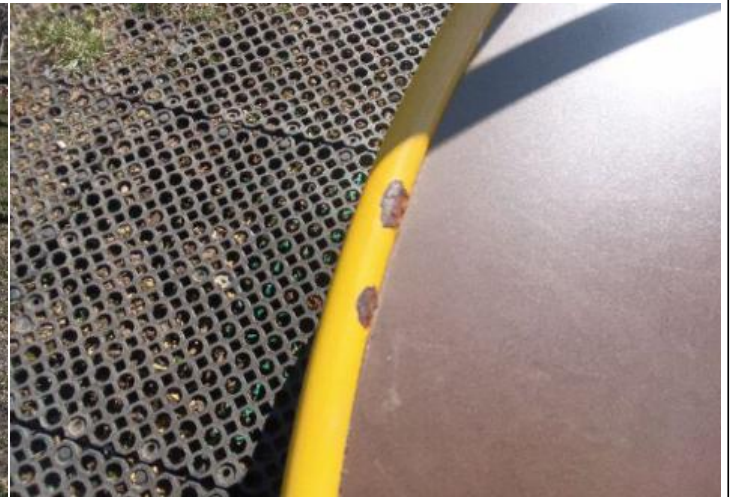
Finding: The paintwork on this item has been damaged or worn exposing the metal underneath which is rusting / corroding

Action: Treat affected areas and repaint

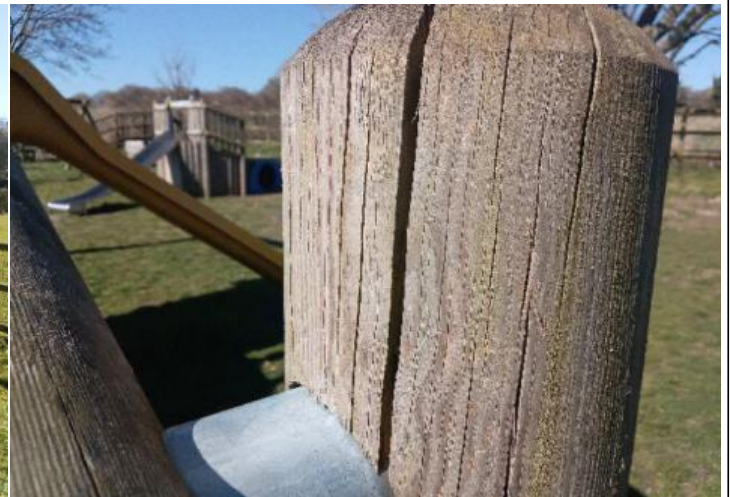
Finding: The timber has a number of splits/shakes or air cracks and this may affect the stability or allow water ingress which will accelerate the rotting process
Action: Monitor to ensure the splits do not cross through fixing points of the structure and/or cause any instability

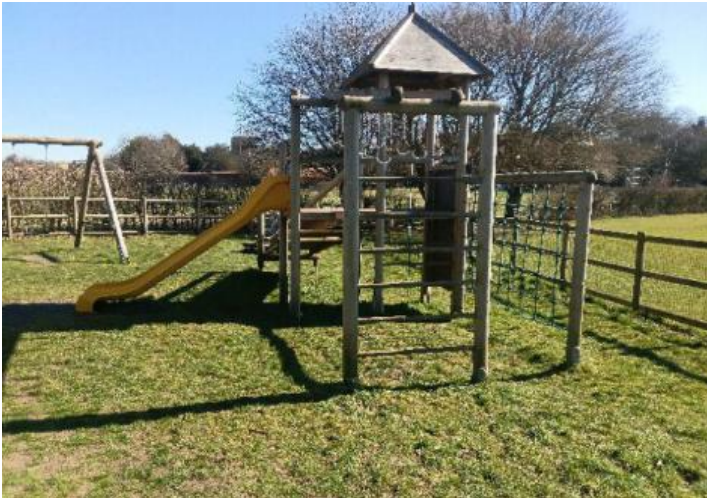
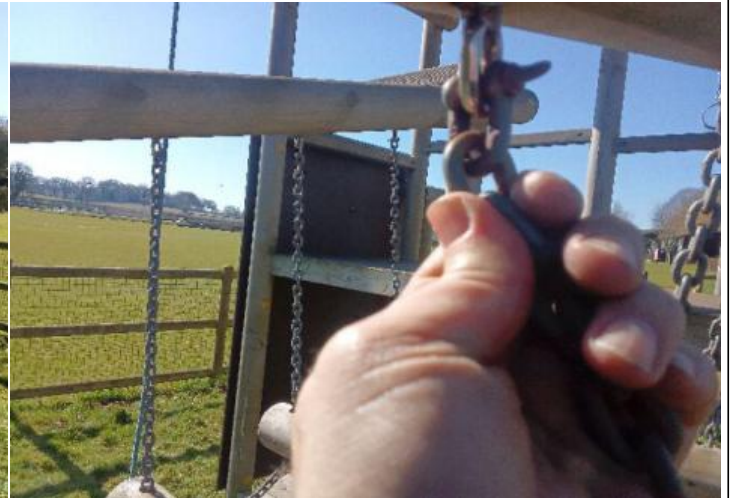
Finding: There is some notable evidence of chain wear

Action: Monitor for any further deterioration and replace when 40% worn

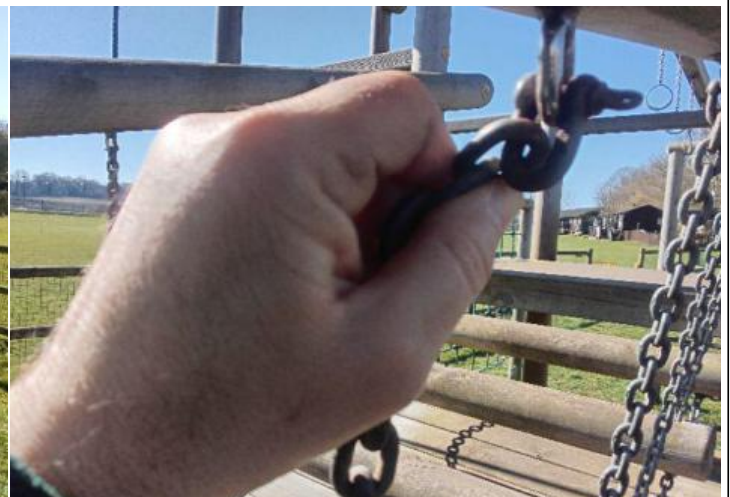
Finding: There is some wear to the shackles.

Action: Monitor for any further deterioration and replace when 40% worn

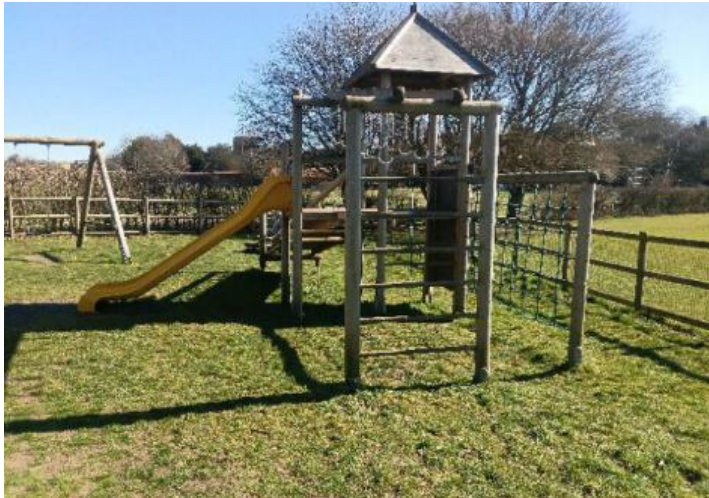
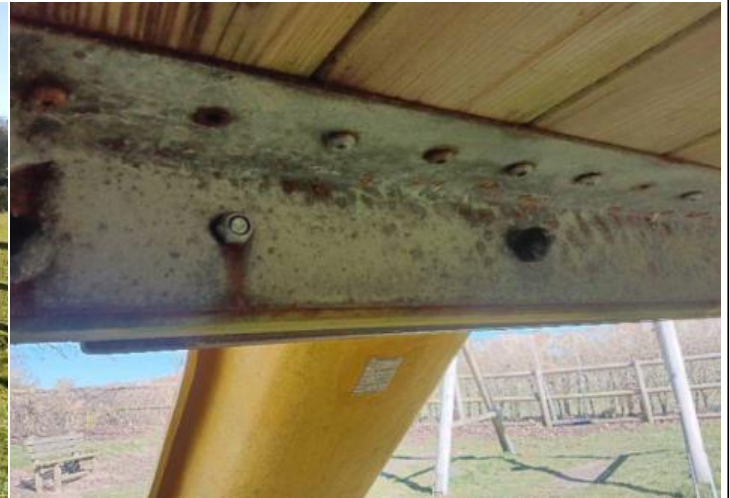
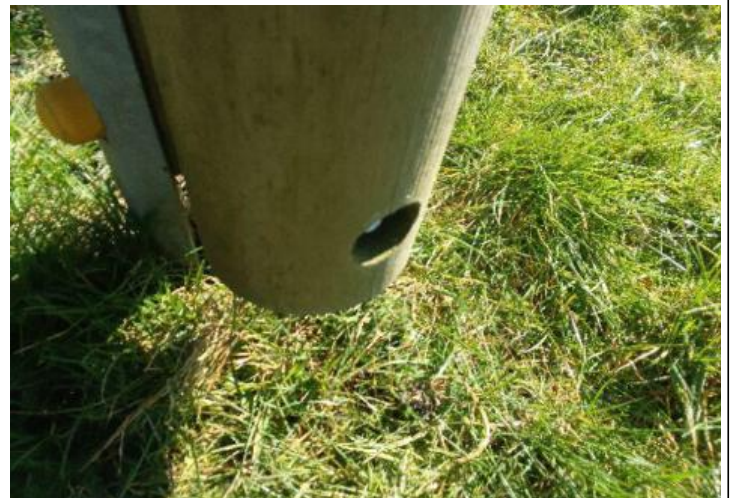
Finding: There is/are bolt cap covers missing or damaged on the item

Action: Replace missing or damaged bolt cap covers

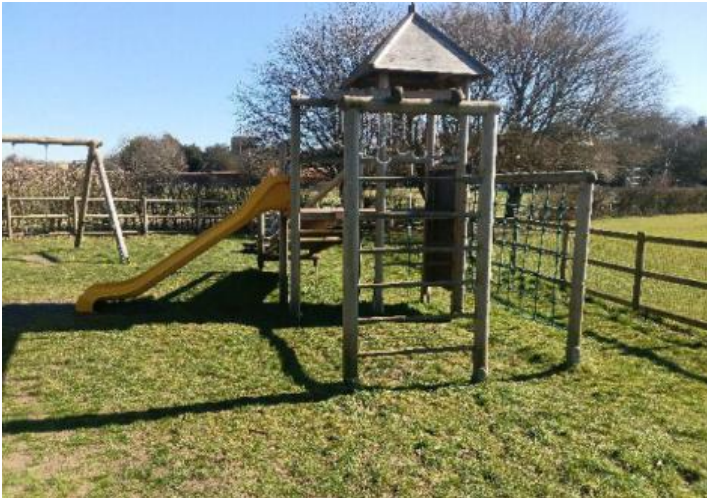
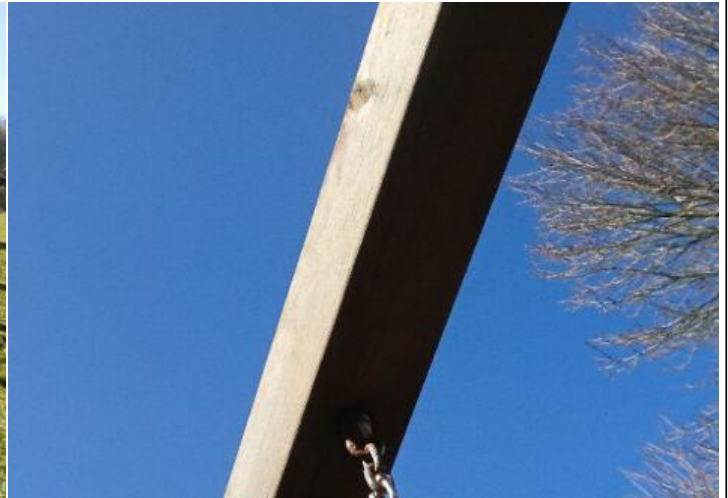
Finding: There is some wear to the connecting links

Action: Monitor for any further deterioration and replace when 40% worn
