Annual Inspection

Winchester City Council

Recreation Ground (Cheriton PC)

Westfield Road, Cheriton, Arlesford, Hampshire, SO24
0QH

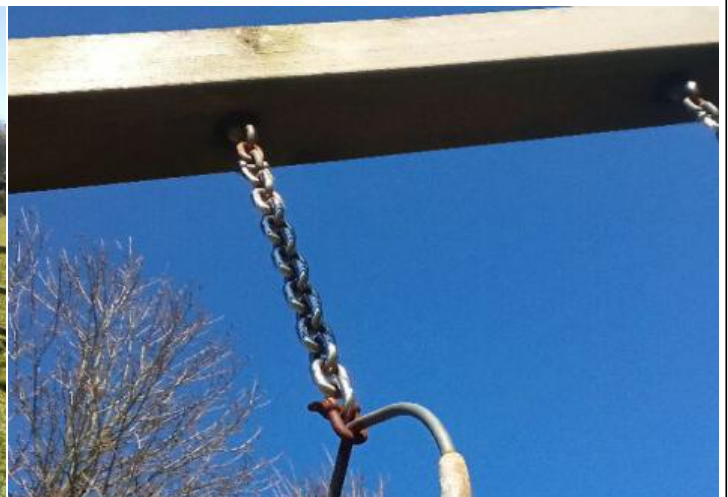
Finding: The shackles have corroded excessively

Action: Replace

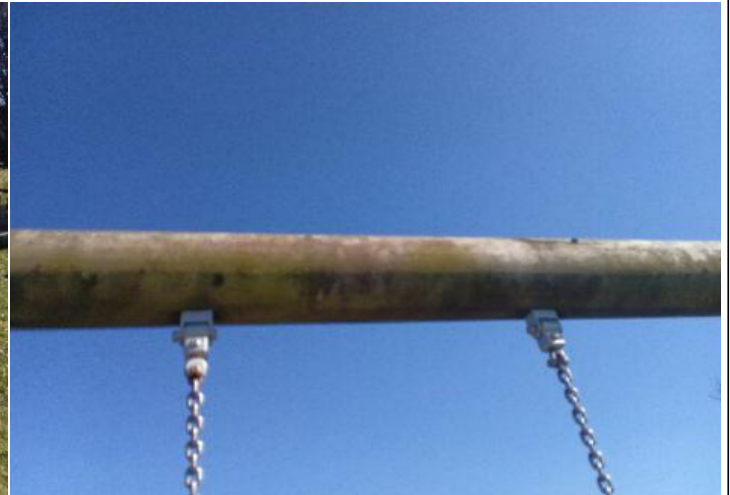
Finding: This design of swing joint has been known to fail on the weld connecting the joint to the threaded stud

Action: We would recommend that the joint be dismantled and checked on a regular basis or consulting with manufacturer on whether a Secondary Safety Device can be fitted

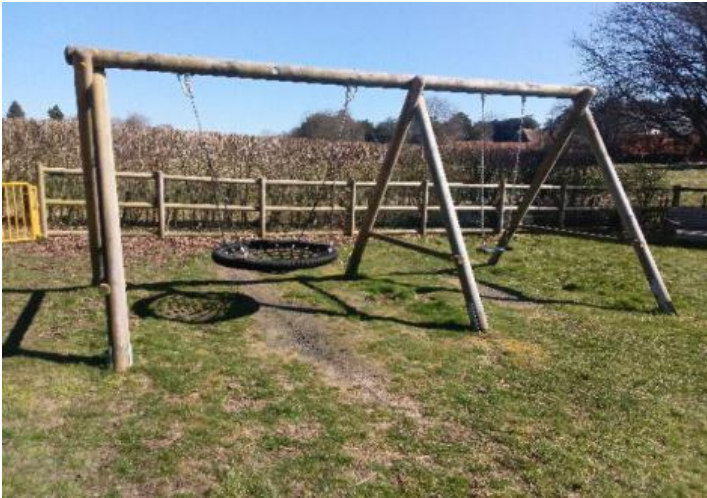
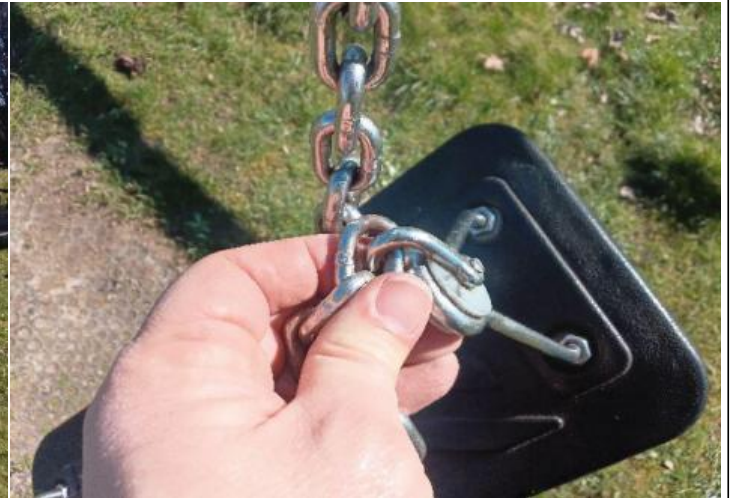
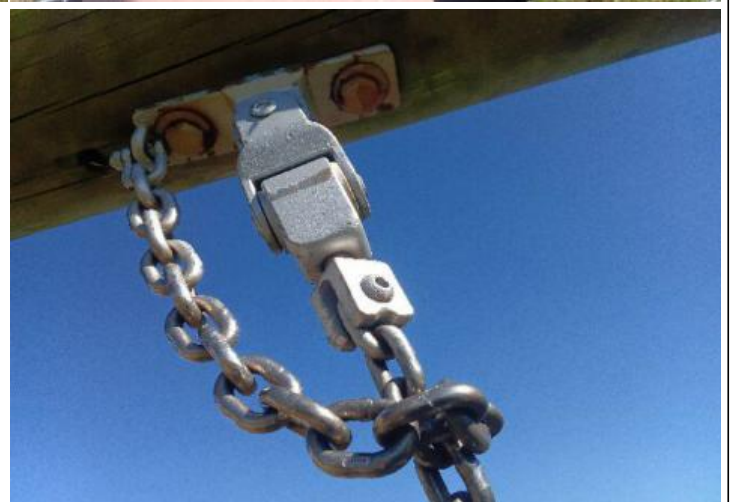
Finding: There is some notable evidence of chain wear

Action: Monitor for any further deterioration and replace when 40% worn

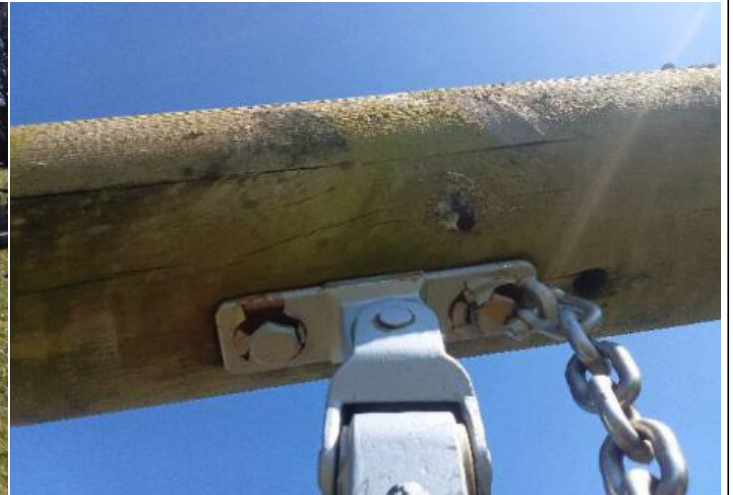
Finding: The paintwork on this item has been damaged or worn exposing the metal underneath which is rusting / corroding

Action: Treat affected areas and repaint

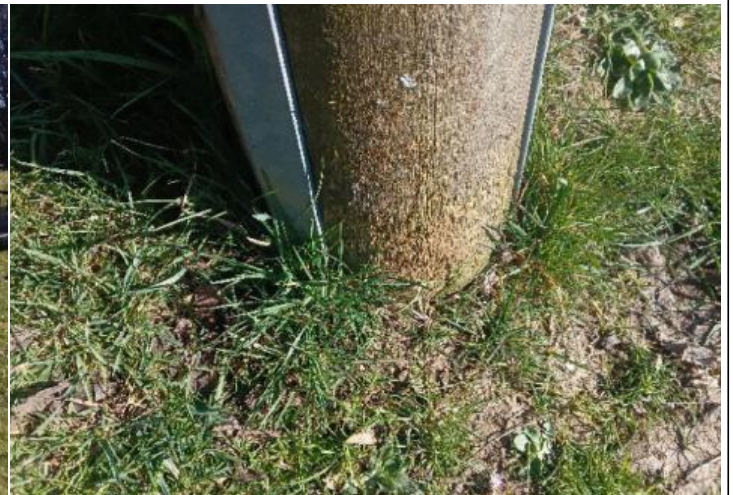
Finding: There is some strimmer / machinery damage apparent on the posts, this can penetrate the preservative applied to the timber and accelerate the rotting process

Action: Monitor for any deterioration (rot) and replace as required

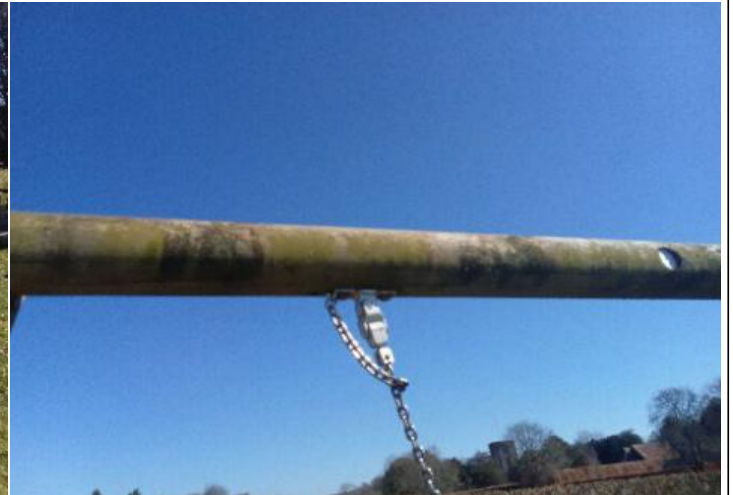
Finding: There is algae or moss on the surface of the equipment that can lead to the onset of rot

Action: Monitor condition of the timbers (rot), clean and treat appropriately

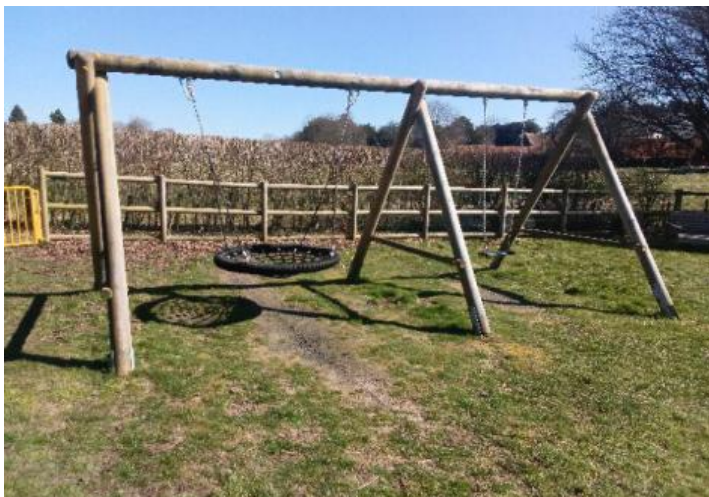
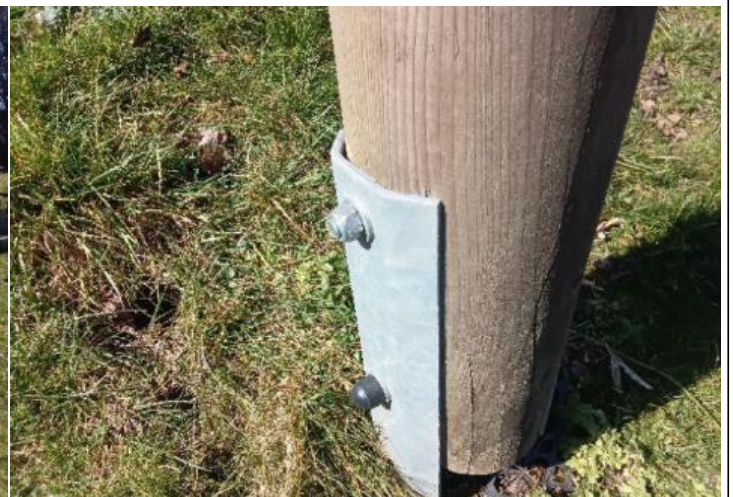
Finding: There is/are bolt cap covers missing or damaged on the item

Action: Replace missing or damaged bolt cap covers

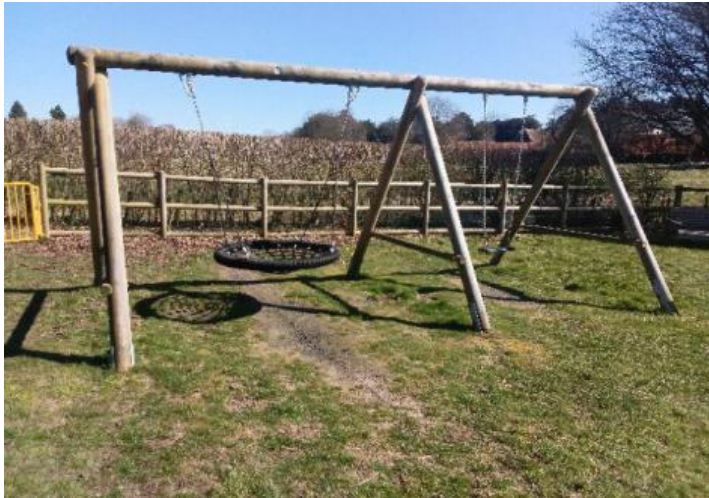
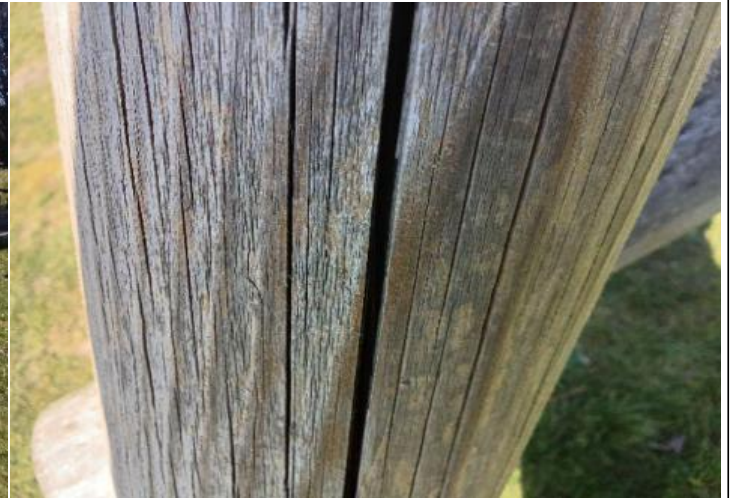
Finding: The timber has a number of splits/shakes or air cracks and this may affect the stability or allow water ingress which will accelerate the rotting process
Action: Monitor to ensure the splits do not cross through fixing points of the structure and/or cause any instability
