Annual Inspection

Winchester City Council

Recreation Ground (Cheriton PC)

Westfield Road, Cheriton, Arlesford, Hampshire, SO24
0QH

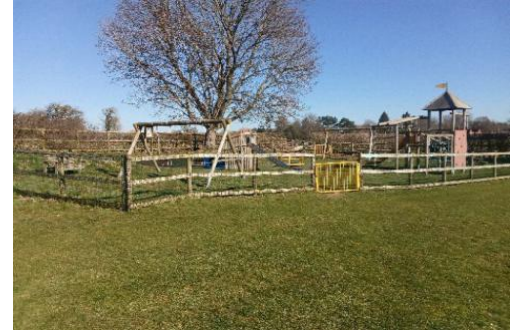
Item: Site General
Manufacturer: Owner/Operator
Surface Type: N/A
Item Quantity: 1
Equipment Compliance: N/A
Surface Area Compliance: N/A

It is recommended that signage, with information including the site address, contact information for maintenance issues and emergency contact details are provided for the facility - Provide in accordance with the recommendations

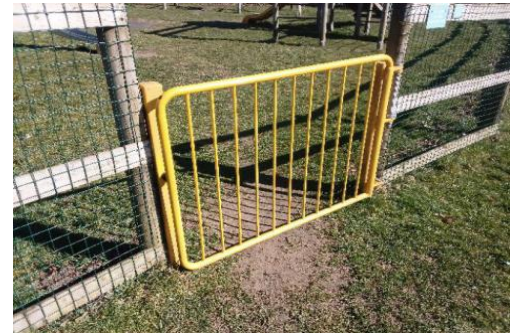
Item: Gate - Self Closing
Manufacturer: I.A.E. Fencing
Surface Type: Mixed Surface
Item Quantity: 2
Equipment Compliance: N/A
Surface Area Compliance: N/A

There is a missing fixing and a bracket has slipped out of place with sharp edges - Repair

The surface has eroded in some areas and may be slippery in wet conditions - Reinstate the surface

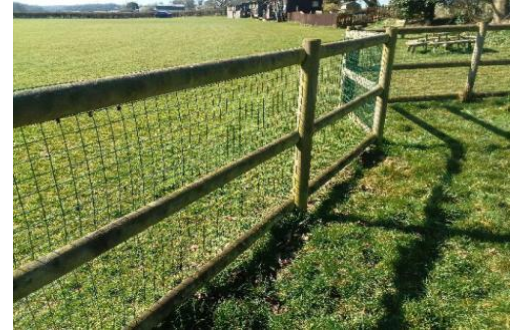
Item: Fence - Timber & Mesh Infill
Manufacturer: Not Identified
Surface Type: Grass
Item Quantity: 1
Equipment Compliance: N/A
Surface Area Compliance: N/A

There is some evidence of rot in the timber - Monitor for any further deterioration and replace as required

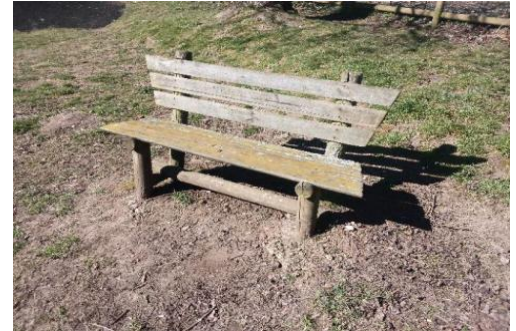
Item: Bench
Manufacturer: Not Identified
Surface Type: Grass
Item Quantity: 2
Equipment Compliance: N/A
Surface Area Compliance: N/A

The surface has eroded and the foundations are exposed - Reinstate surrounding surfaces to cover the foundations

The timber has a number of splits/shakes or air cracks and this may affect the stability or allow water ingress which will accelerate the rotting process - Monitor to ensure the splits do not cross through fixing points of the structure and/or cause any instability

There is some strimmer / machinery damage apparent on the posts, this can penetrate the preservative applied to the timber and accelerate the rotting process - Monitor for any deterioration (rot) and replace as required

There is some evidence of rot in the timber - Monitor for any further deterioration and replace as required

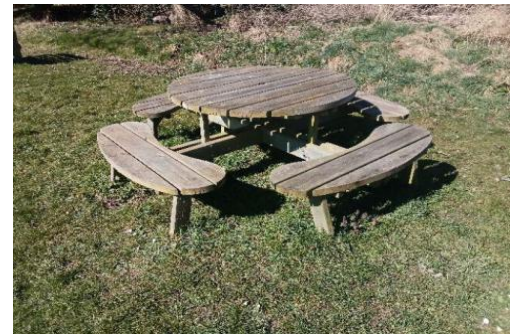
Item: Picnic Table
Manufacturer: Not Identified
Surface Type: Grass
Item Quantity: 2
Equipment Compliance: N/A
Surface Area Compliance: N/A

There is some strimmer / machinery damage apparent on the posts, this can penetrate the preservative applied to the timber and accelerate the rotting process - Monitor for any deterioration (rot) and replace as required

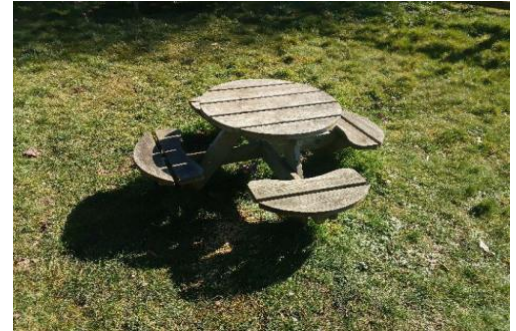
Item: Picnic Table
Manufacturer: Not Identified
Surface Type: Grass
Item Quantity: 1
Equipment Compliance: N/A
Surface Area Compliance: N/A

A number of fixing(s) have worked loose - Secure all loose fixings

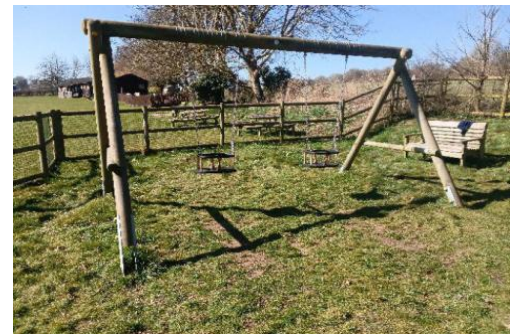
Item: 1 Bay 2 Seat (Cradle)
Manufacturer: Obra
Surface Type: Grass Matrix Tiles
Item Quantity: 1
Equipment Compliance: No
Surface Area Compliance: Yes

There is algae or moss on the surface of the equipment that can lead to the onset of rot - Monitor condition of the timbers (rot), clean and treat appropriately

The timber has a number of splits/shakes or air cracks and this may affect the stability or allow water ingress which will accelerate the rotting process - Monitor to ensure the splits do not cross through fixing points of the structure and/or cause any instability

There is some notable evidence of chain wear - Monitor for any further deterioration and replace when 40% worn

The fixings have corroded excessively - Replace all corroded fixings

A number of shackle fixing(s) have worked loose - Secure all loose fixings

The chain openings are in excess of the 8.6mm as recommended by BS EN 1176 - Monitor - No action given the risk assessment

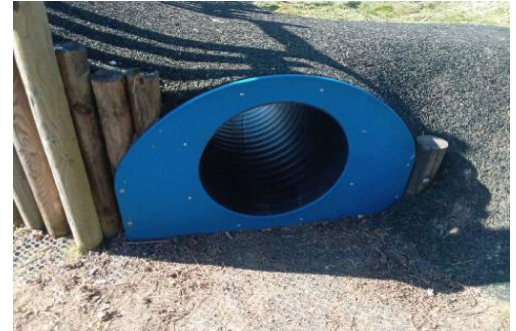
Item: Tunnel Mound
Manufacturer: Obra
Surface Type: Grass Matrix Tiles
Item Quantity: 1
Equipment Compliance: No
Surface Area Compliance: Yes

This design / configuration of tunnel mound is well established and has been successfully included in large quantities of playgrounds throughout the UK. Whilst the design does not fully meet the requirements of BS EN 1176 with regards to falls in excess of 600mm over the edge of the tunnel to the surface below, it has been risk assessed as fit for purpose in this regard and no changes are recommended to the design unless otherwise stated in additional findings - Monitor - No action given the risk assessment

There is some damage to the tunnel surface - Monitor for any further deterioration and repair as required

There are areas or parts of the timber on the structure that have rotted - Replace all affected timbers

There is some evidence of rot in the timber - Monitor for any further deterioration and replace as required

There are significant gaps (over 30mm) between the surface and the edging or between the joints in the surface; these are large enough for a small foot to enter - Repair surfacing

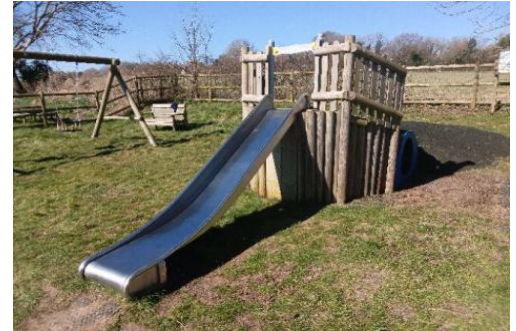
Item: Multi Play (Junior)
Manufacturer: Obra
Surface Type: Grass Matrix Tiles
Item Quantity: 1
Equipment Compliance: No
Surface Area Compliance: Yes

There is some strimmer / machinery damage apparent on the posts, this can penetrate the preservative applied to the timber and accelerate the rotting process - Monitor for any deterioration (rot) and replace as required

The timber has a number of splits/shakes or air cracks and this may affect the stability or allow water ingress which will accelerate the rotting process - Monitor to ensure the splits do not cross through fixing points of the structure and/or cause any instability

There is some evidence of rot in the timber - Monitor for any further deterioration and replace as required

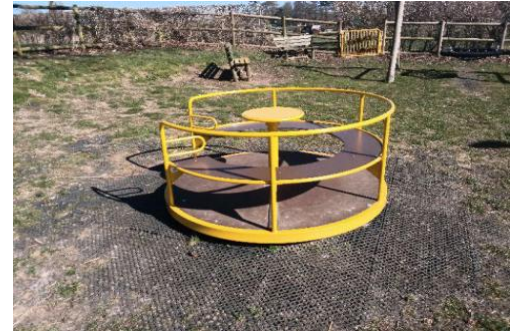
Item: Roundabout
Manufacturer: Obra
Surface Type: Grass Matrix Tiles
Item Quantity: 1
Equipment Compliance: No
Surface Area Compliance: Yes

The surface has subsided in some areas - Monitor for any further deterioration and repair as required

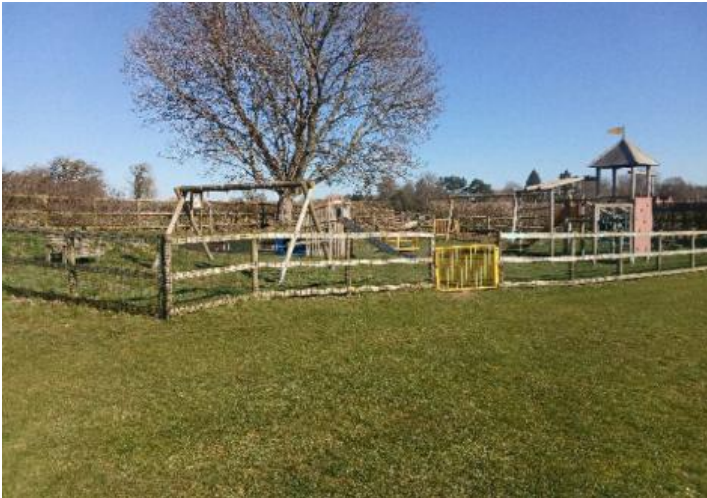
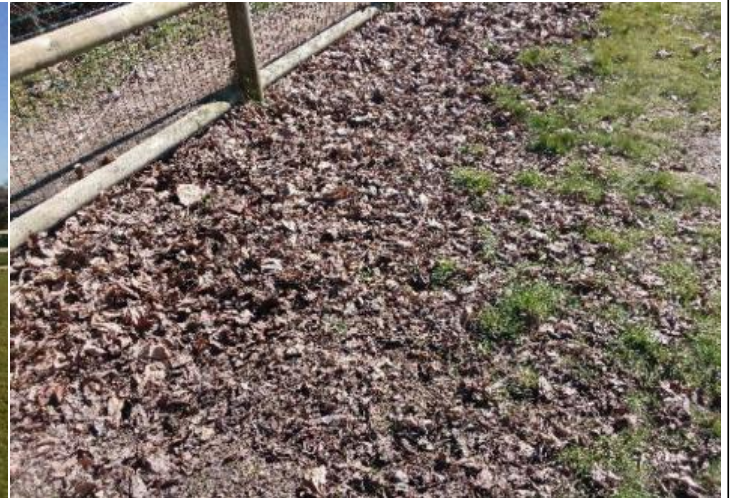
Item: Ancillary Items - Site General
Manufacturer: Owner/Operator

Finding: There is some tree debris on the surfacing

Action: Remove and maintain

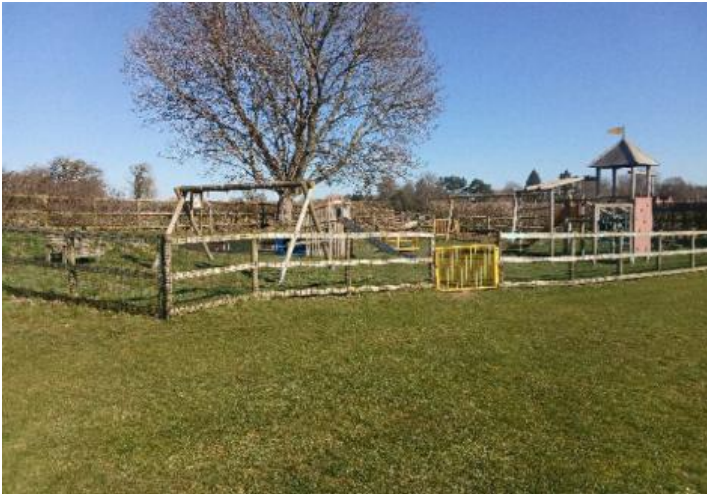
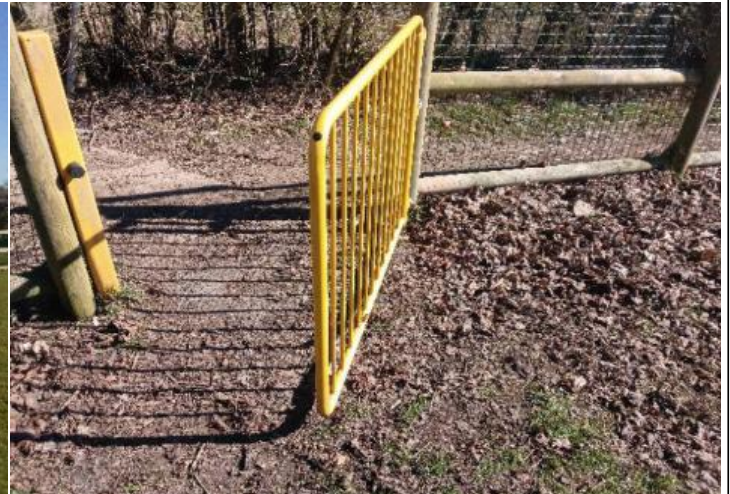
Item: Ancillary Items - Site General
Manufacturer: Owner/Operator

Finding: The gate is not operating correctly

Action: Take effective action to ensure the gate closes between 4 and 8 seconds

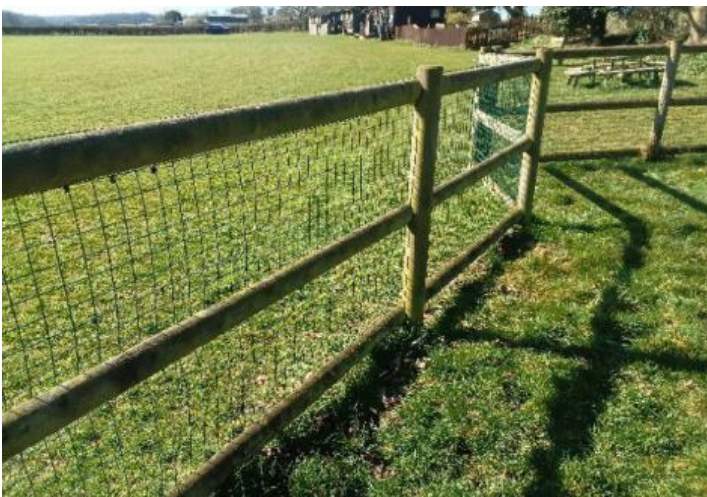
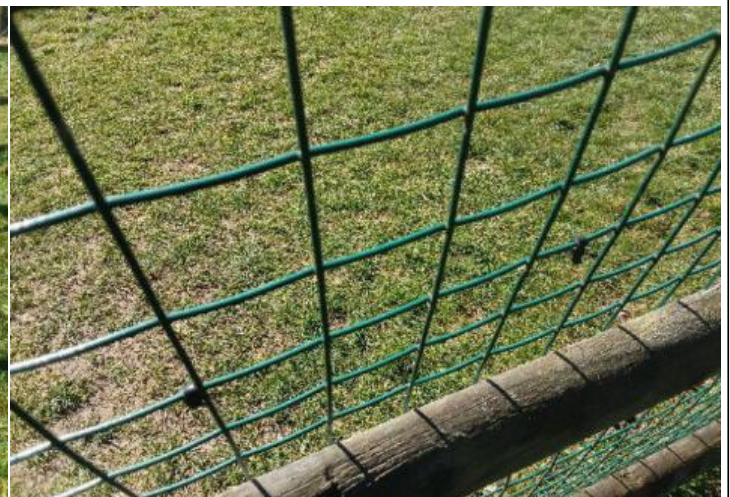
Item: Fences - Fence - Timber & Mesh Infill
Manufacturer: Not Identified

Finding: There are cable ties attached to the fencing

Action: Remove

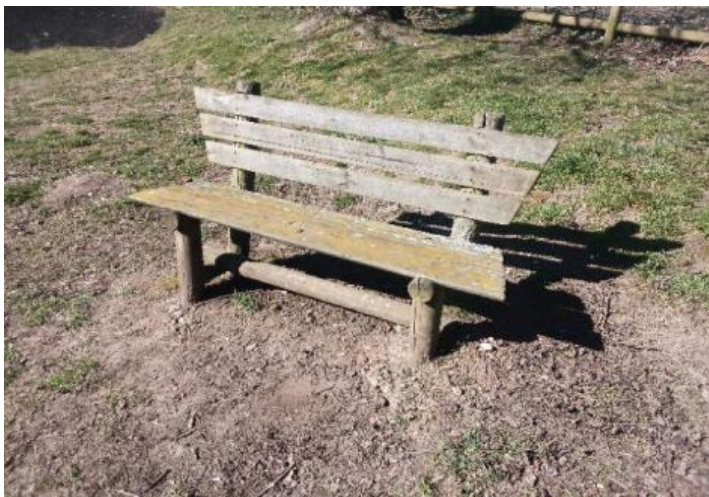
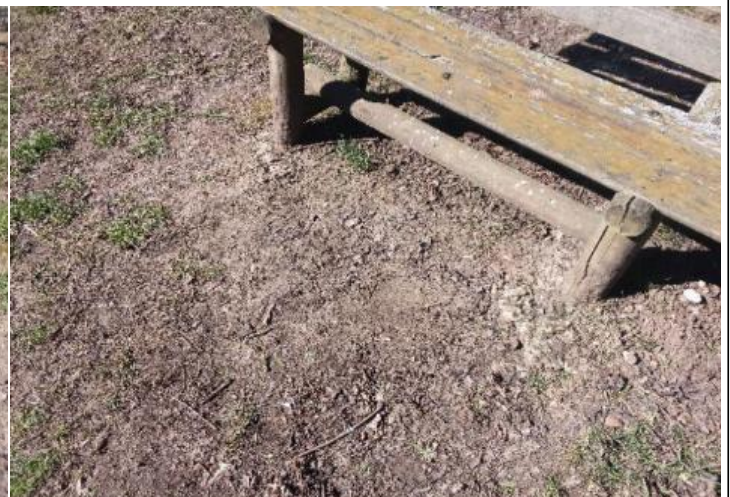
Item: Ancillary Items - Bench
Manufacturer: Not Identified

Finding: The area around the item has eroded and may become slippery

Action: Reinstate eroded area

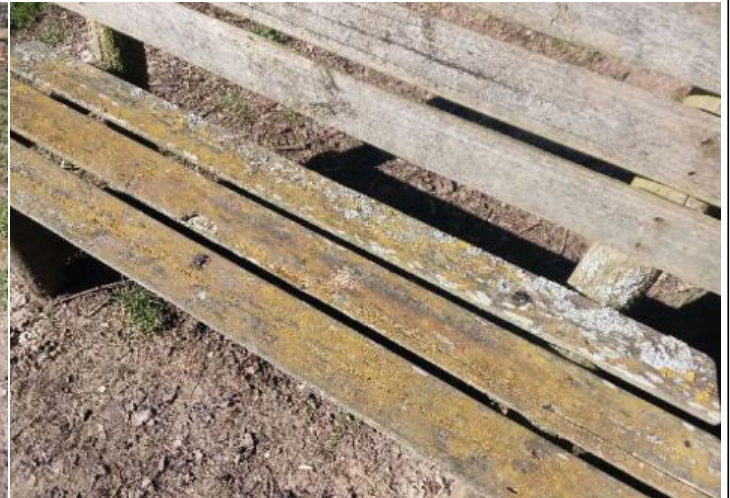
Item: Ancillary Items - Bench
Manufacturer: Not Identified

Finding: There is algae or moss on the surface of the equipment

Action: Clean and treat appropriately

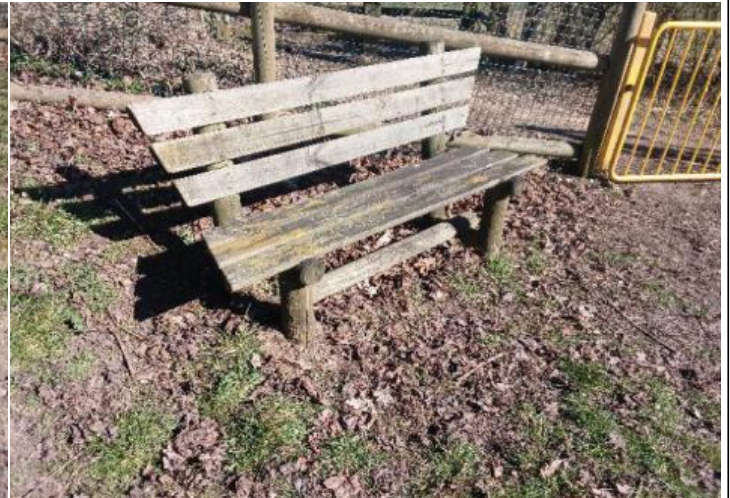
Item: Ancillary Items - Bench
Manufacturer: Not Identified

Finding: The seat is not level

Action: Adjust as required

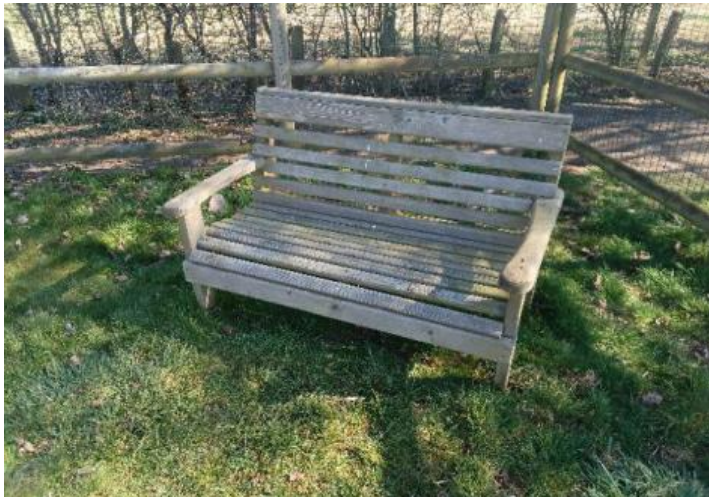
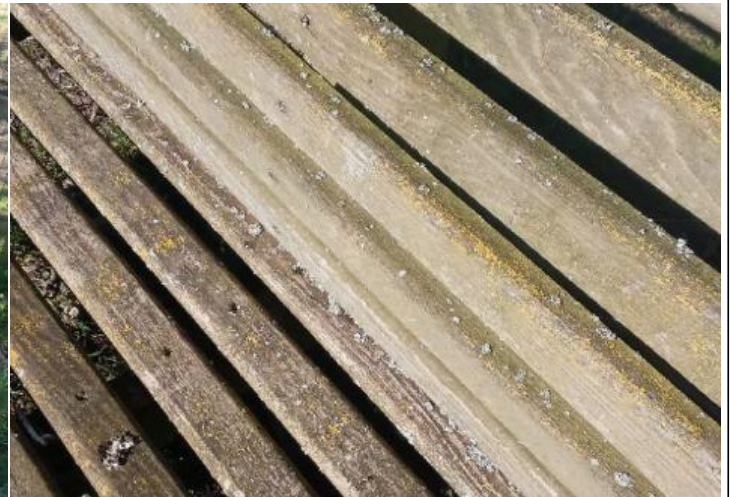
Item: Ancillary Items - Bench
Manufacturer: Not Identified

Finding: There is algae or moss on the surface of the equipment

Action: Clean and treat appropriately

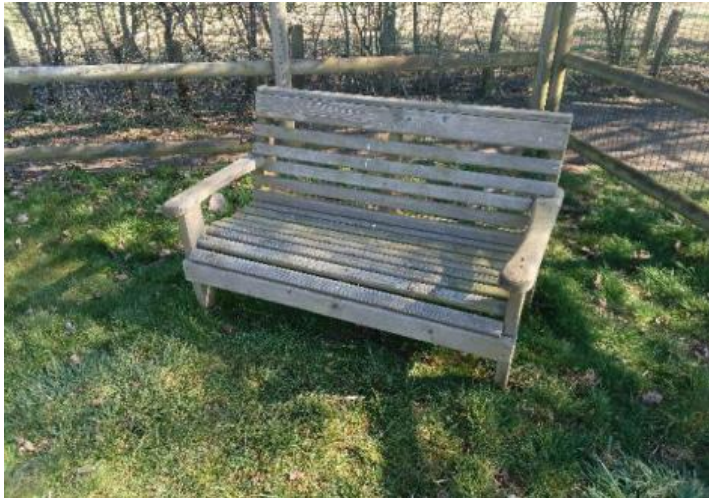
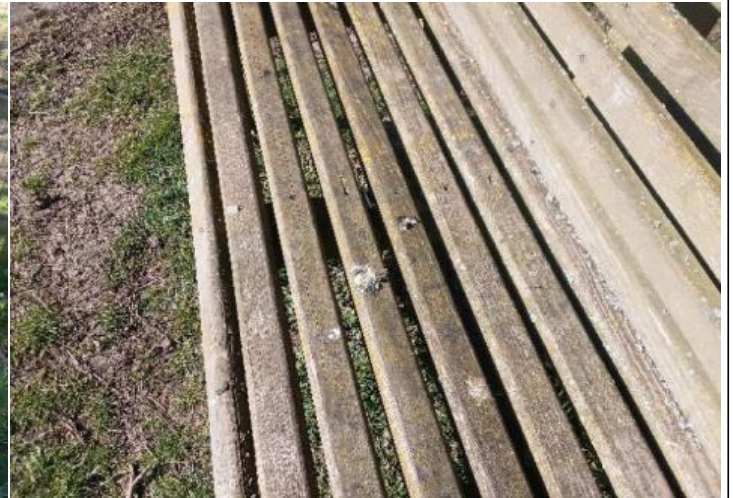
Item: Ancillary Items - Bench
Manufacturer: Not Identified

Finding: There is bird excrement on the bench

Action: Clean and maintain area

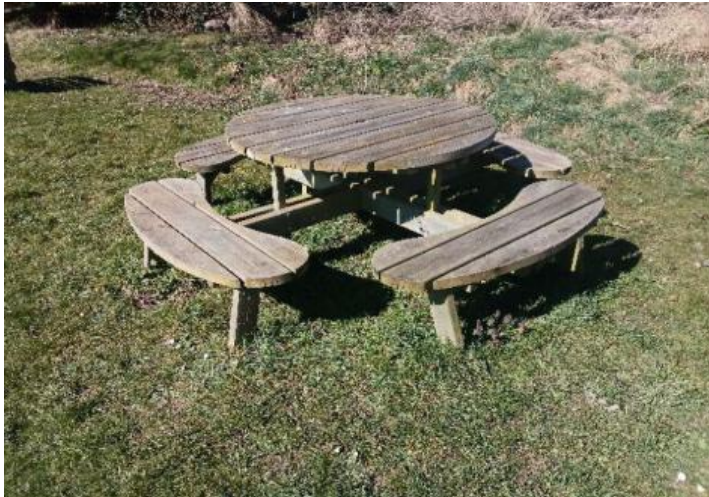
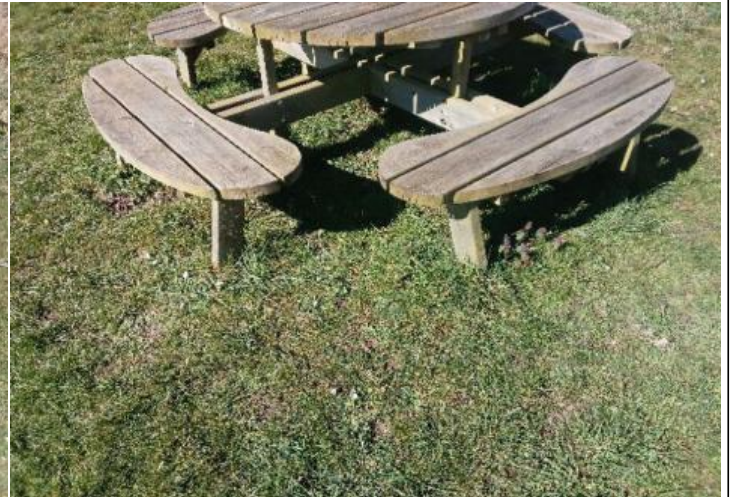
Item: Ancillary Items - Picnic Table
Manufacturer: Not Identified

Finding: The table/s is/are not secured to the ground and there is some potential for the item/s to be moved within falling spaces of equipment

Action: Secure to the ground

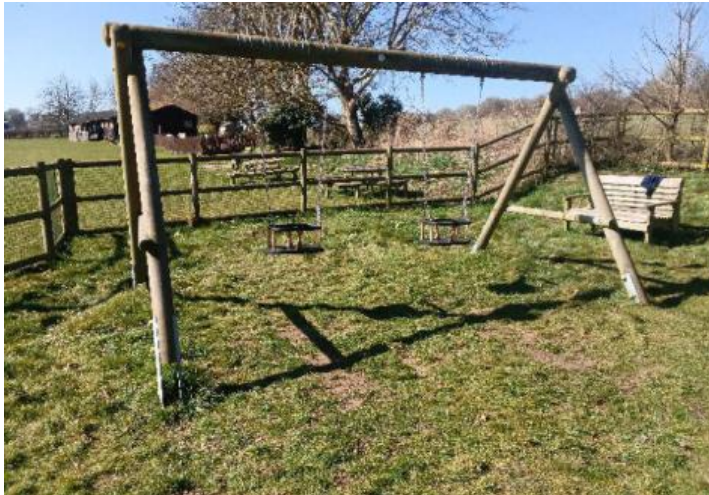
Item: Swings - 1 Bay 2 Seat (Cradle)
Manufacturer: Obra

Finding: There is algae or moss on the surface of the equipment that can lead to the onset of rot

Action: Monitor condition of the timbers (rot), clean and treat appropriately

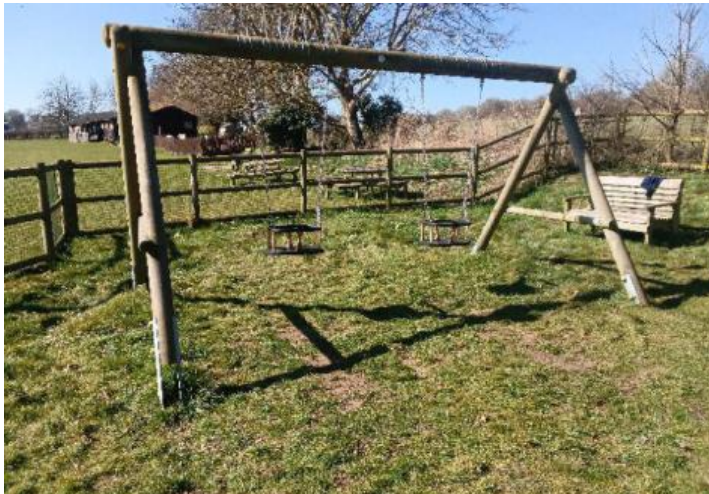
Item: Swings - 1 Bay 2 Seat (Cradle)
Manufacturer: Obra

Finding: The timber has a number of splits/shakes or air cracks and this may affect the stability or allow water ingress which will accelerate the rotting process

Action: Monitor to ensure the splits do not cross through fixing points of the structure and/or cause any instability

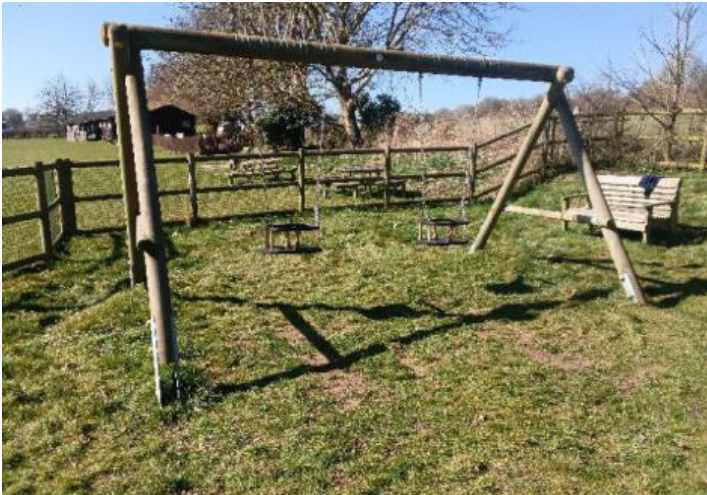
Item: Swings - 1 Bay 2 Seat (Cradle)
Manufacturer: Obra

Finding: A number of shackle fixing(s) have worked loose **Action:** Secure all loose fixings

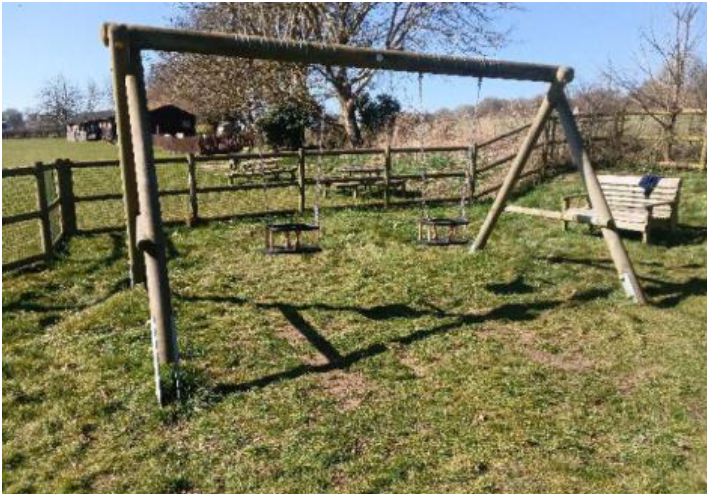
Item: Swings - 1 Bay 2 Seat (Cradle)
Manufacturer: Obra

Finding: The chain openings are in excess of the 8.6mm as recommended by BS EN 1176 **Action:** Monitor - No action given the risk assessment

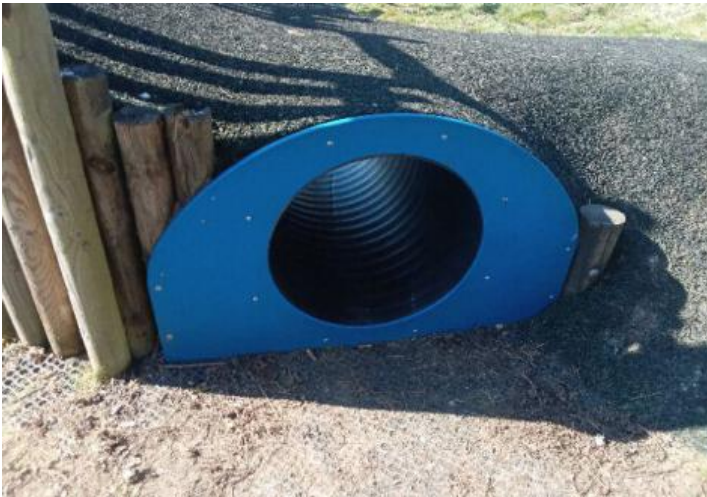
Item: Other - Tunnel Mound
Manufacturer: Obra

Finding: There are significant gaps (over 30mm) between the surface and the edging or between the joints in the surface; these are large enough for a small foot to enter

Action: Repair surfacing

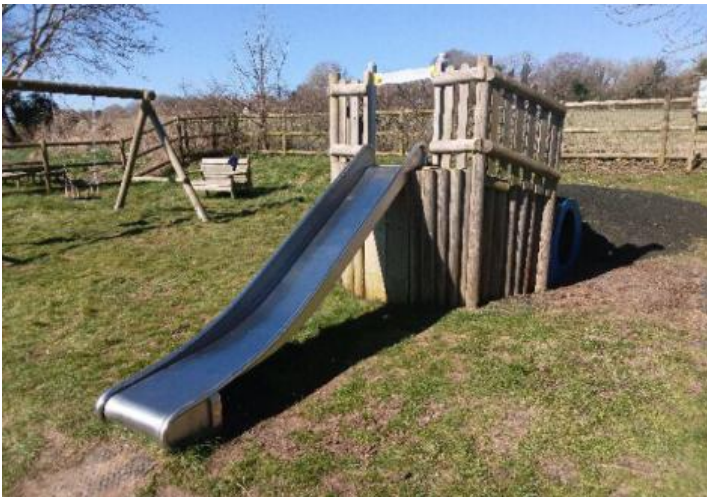
Item: Activity Equipment - Multi Play (Junior)
Manufacturer: Obra

Finding: The timber has a number of splits/shakes or air cracks and this may affect the stability or allow water ingress which will accelerate the rotting process

Action: Monitor to ensure the splits do not cross through fixing points of the structure and/or cause any instability

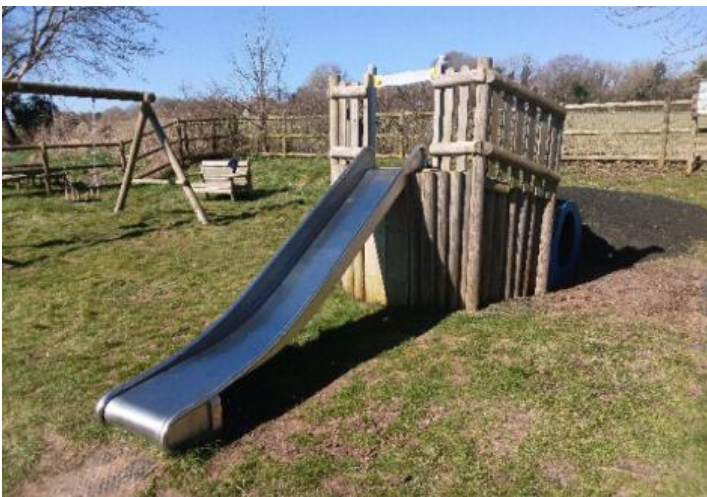
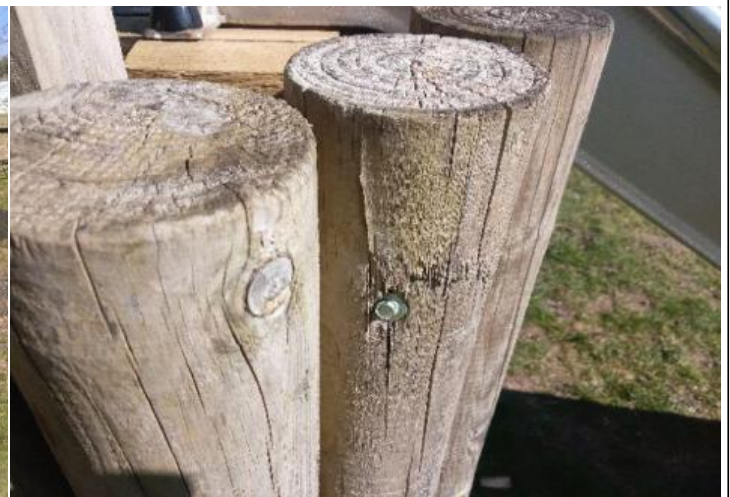
Item: Activity Equipment - Multi Play (Junior)
Manufacturer: Oبرا

Finding: Parts of the timber are rough or splintered

Action: Remove all rough or sharp edges

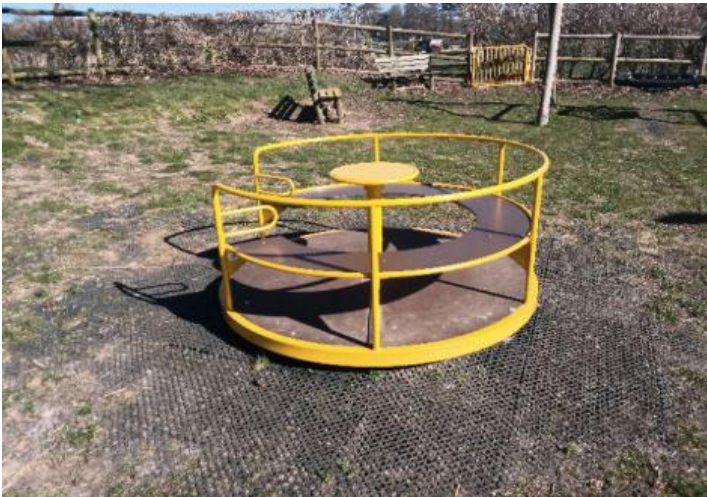
Item: Rotor Play - Roundabout
Manufacturer: Obra

Finding: The paintwork on this item has been damaged or worn exposing the metal underneath which is rusting / corroding

Action: Treat affected areas and repaint

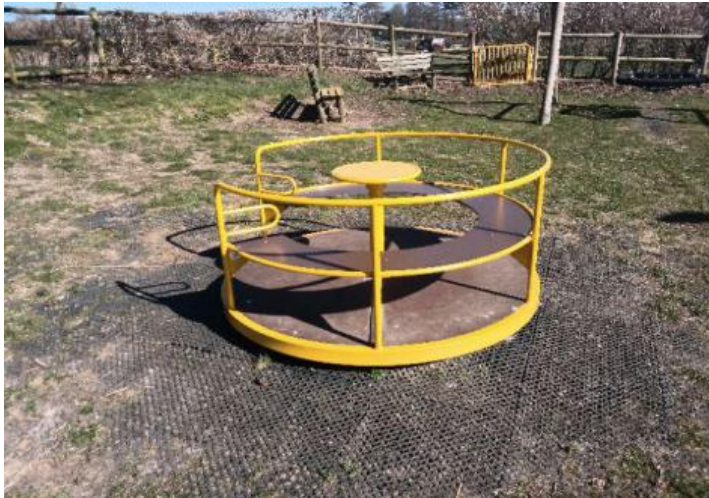
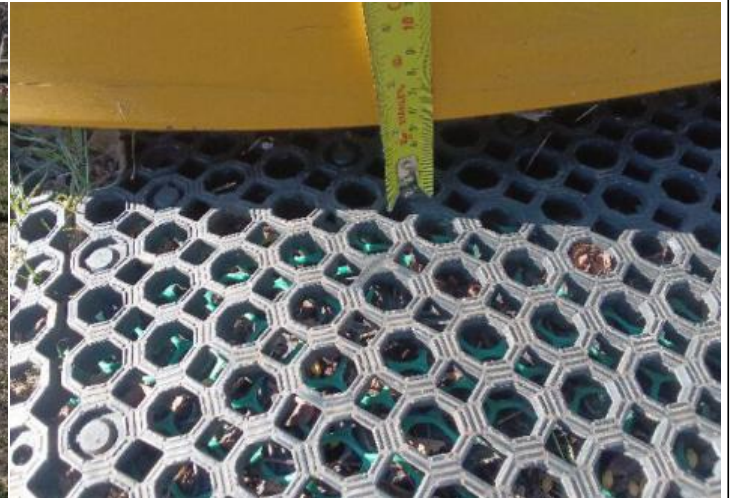
Item: Rotor Play - Roundabout
Manufacturer: Obra

Finding: The distance between the underside of the roundabout platform and the playing surface is less than 60mm and contravenes the requirements of BS EN 1176 Part 5 which requires that the distance be maintained between 60mm-110mm for the entire circumference of the roundabout

Action: Monitor - No action given the risk assessment

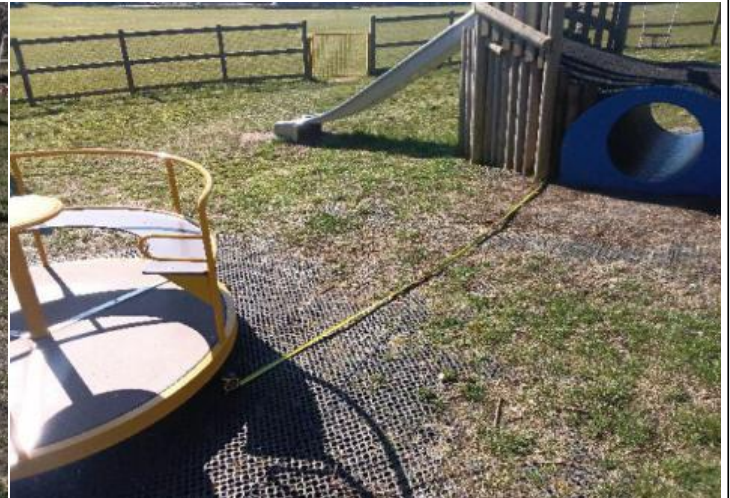
Item: Rotor Play - Roundabout
Manufacturer: Obra

Finding: The falling space overlaps the free space between the tunnel mound and the roundabout in contravention of the requirements of BS EN 1176:2017 Part 1
Action: Monitor - No action given the risk assessment

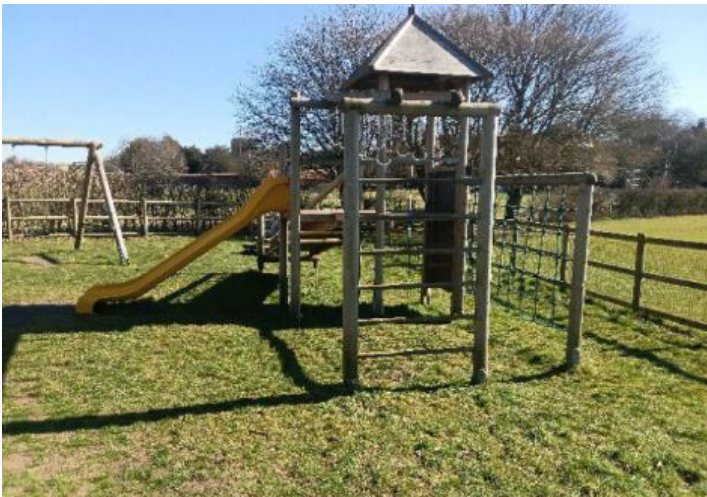
Item: Activity Equipment - Multi Play (Junior)
Manufacturer: Obra

Finding: The timber has a number of splits/shakes or air cracks and this may affect the stability or allow water ingress which will accelerate the rotting process
Action: Monitor to ensure the splits do not cross through fixing points of the structure and/or cause any instability

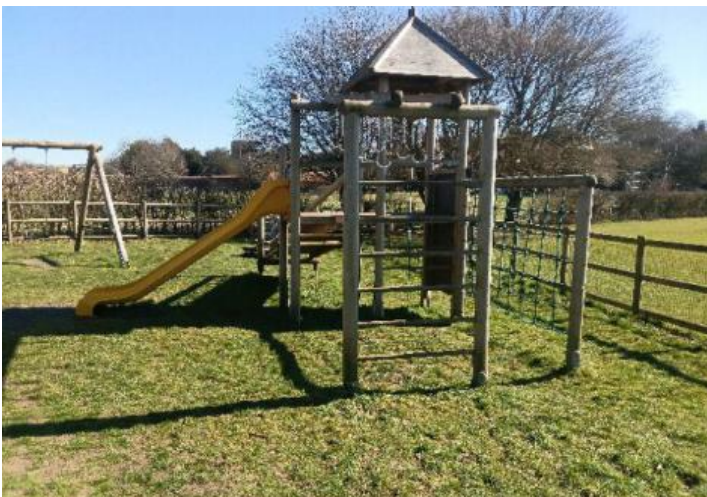
Item: Activity Equipment - Multi Play (Junior)
Manufacturer: Obra

Finding: There is some wear to the shackles.

Action: Monitor for any further deterioration and replace when 40% worn

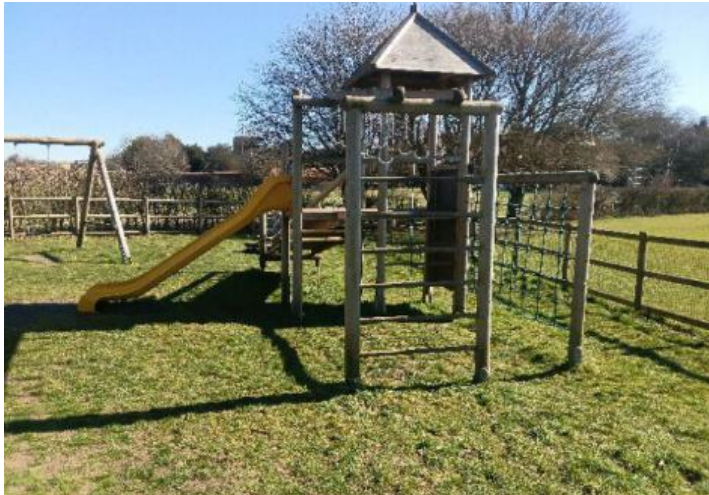
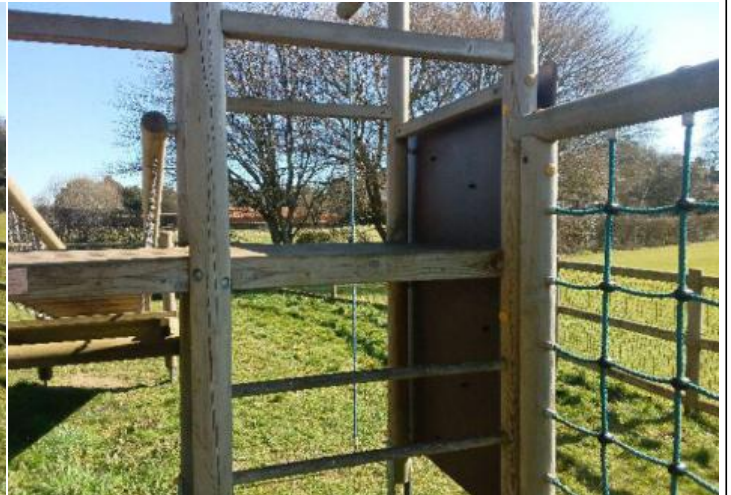
Item: Activity Equipment - Multi Play (Junior)
Manufacturer: Obra

Finding: There are openings leading from platforms in excess of 1.0m in height to steep play elements and no hand supports complying with grip or grasp are provided, in contravention of BS EN 1176 Part 1: 4.2.9.4

Action: Monitor - No action given the risk assessment

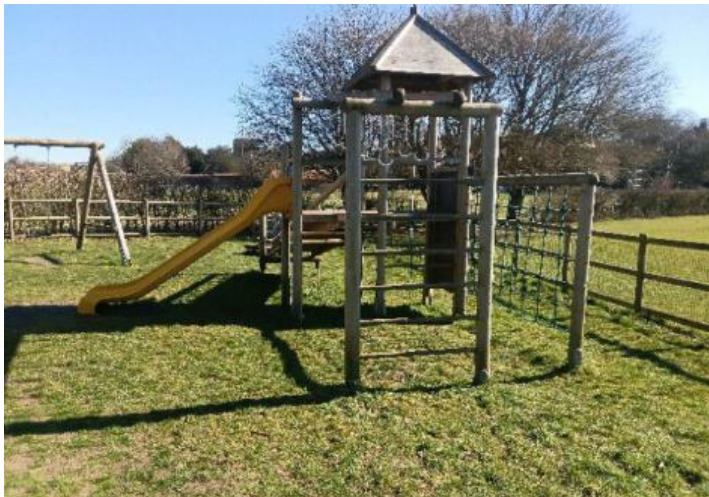
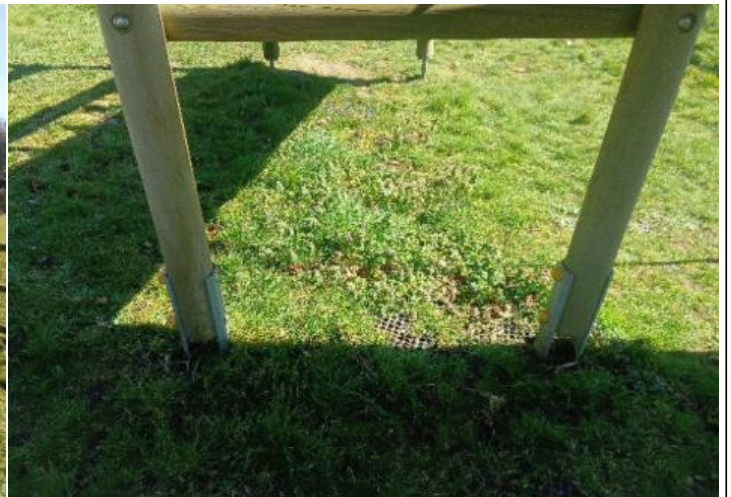
Item: Activity Equipment - Multi Play (Junior)
Manufacturer: Obra

Finding: There is weed / vegetation growth within the surface

Action: Remove weed / vegetation growth

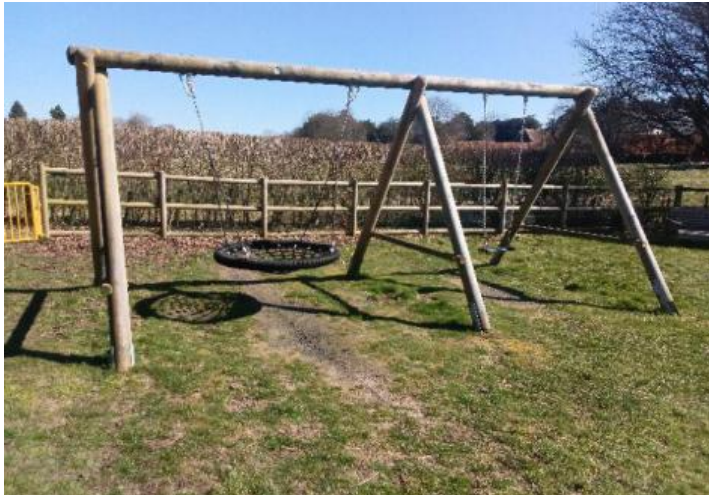
Item: Swings - 2 Bay 1 Flat 1 Basket
Manufacturer: Obra

Finding: This design of swing joint has been known to fail on the weld connecting the joint to the threaded stud

Action: We would recommend that the joint be dismantled and checked on a regular basis or consulting with manufacturer on whether a Secondary Safety Device can be fitted

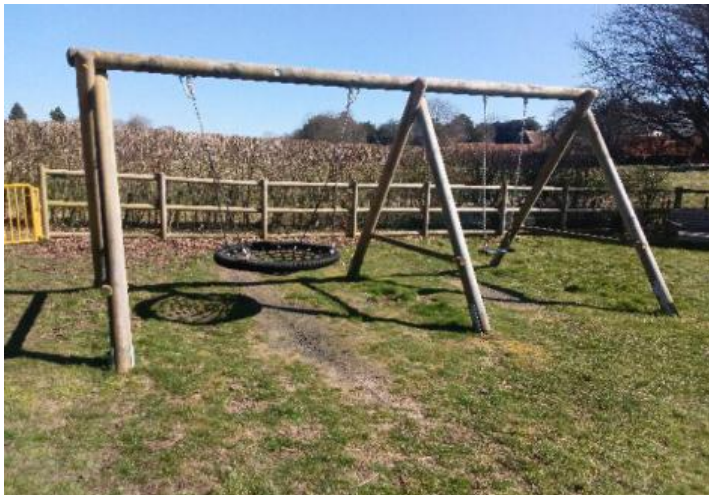
Item: Swings - 2 Bay 1 Flat 1 Basket
Manufacturer: Obra

Finding: There is some strimmer / machinery damage apparent on the posts, this can penetrate the preservative applied to the timber and accelerate the rotting process

Action: Monitor for any deterioration (rot) and replace as required
